Investigation of Shear Distribution Factors in Prestressed Concrete Girder Bridges

Catherine E. W. French, Principal Investigator
Department of Civil, Environmental, and Geo- Engineering
University of Minnesota

Research Project
Final Report 2016-32

Minnesota
Department of
Transportation

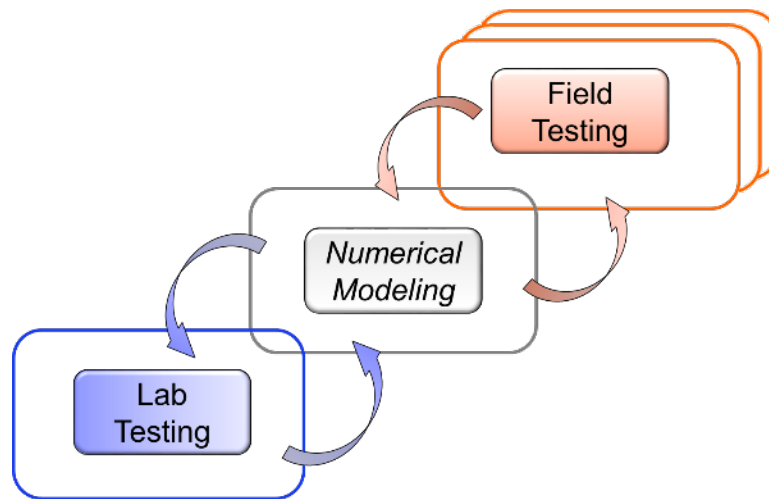
Figure 1.1: Integrated experimental and numerical research techniques

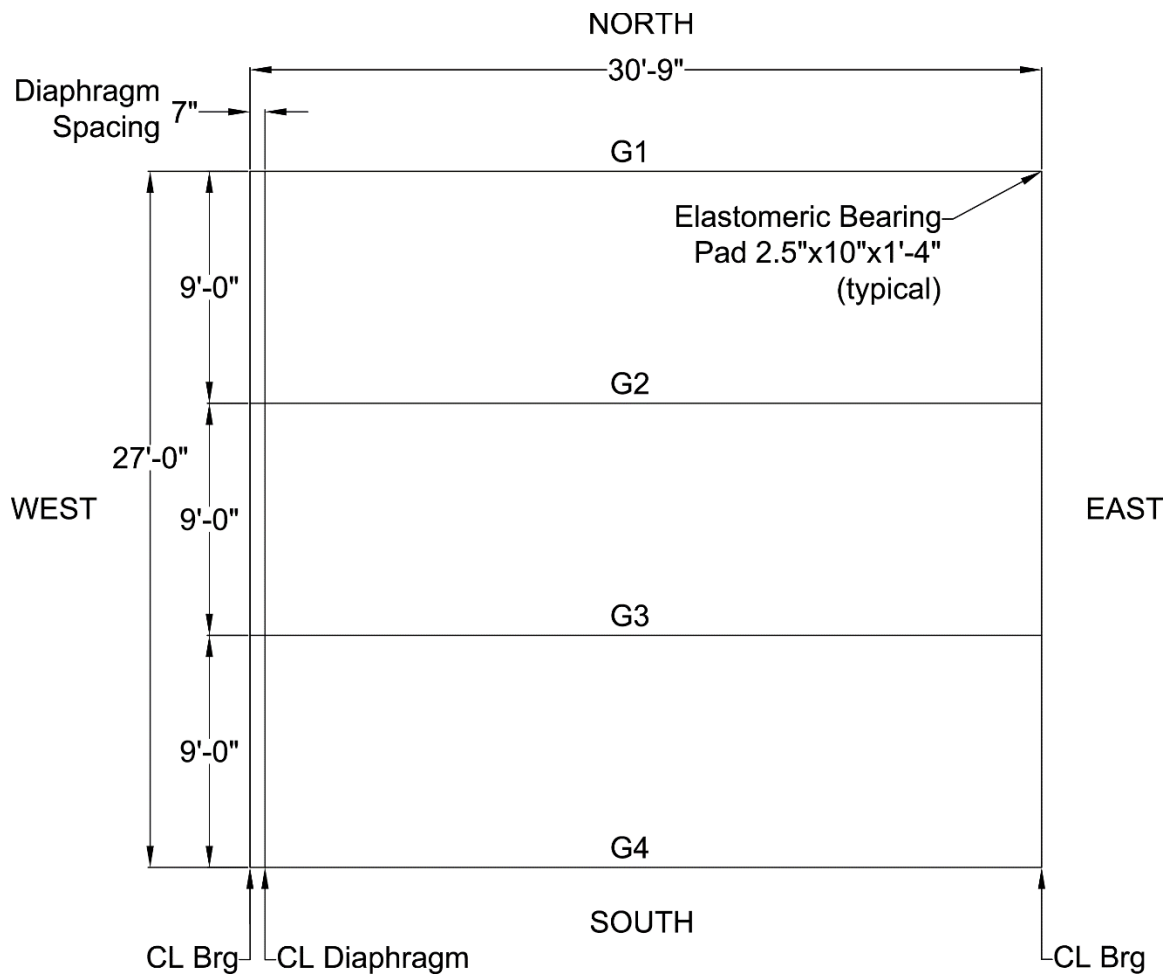
Figure 4.9: Laboratory bridge framing plan

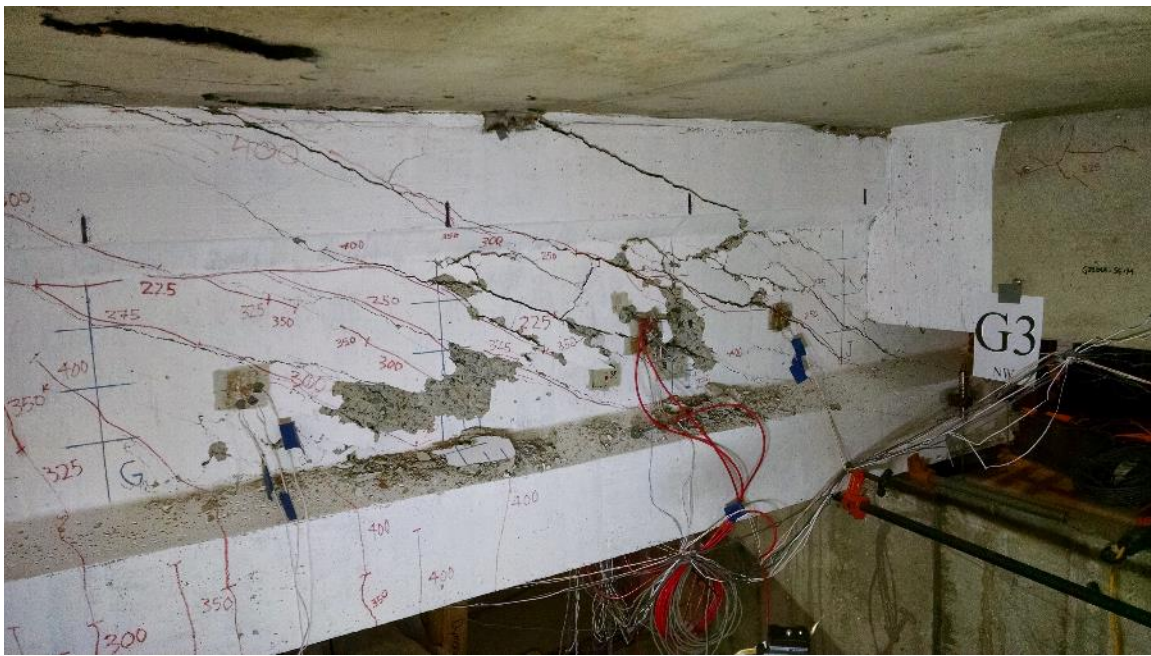
Figure 5.14: Web-shear crushing and deck punching in G3 during LBUW looking south

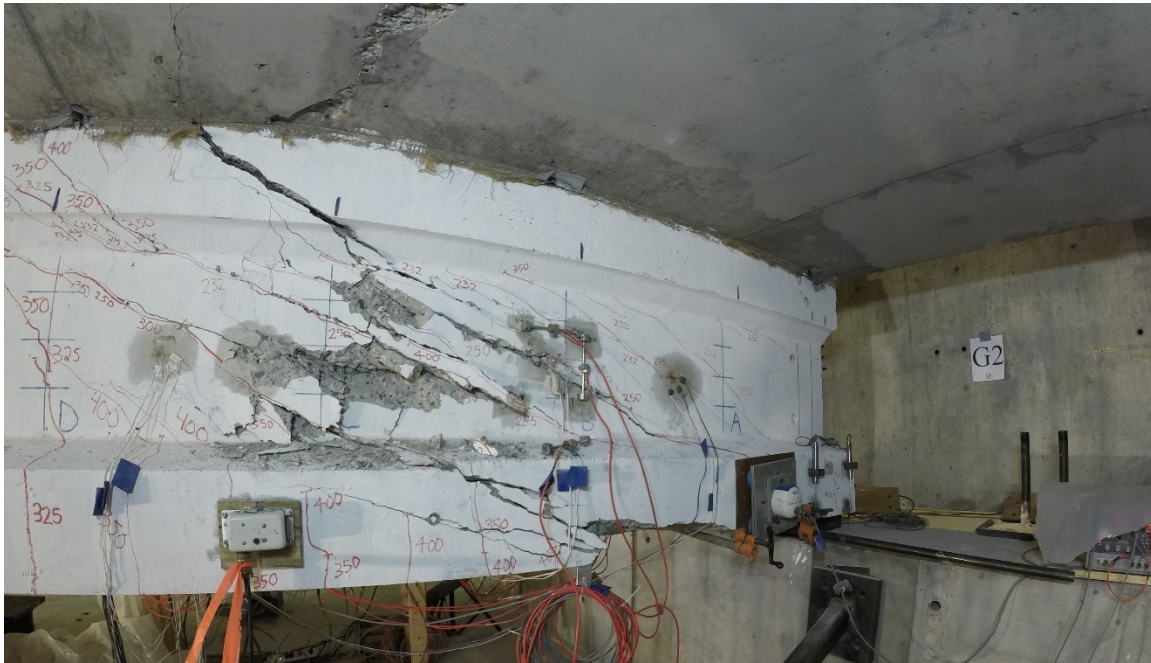
Figure 5.20: Web-shear crushing and deck punching in G2 during LBUE looking north

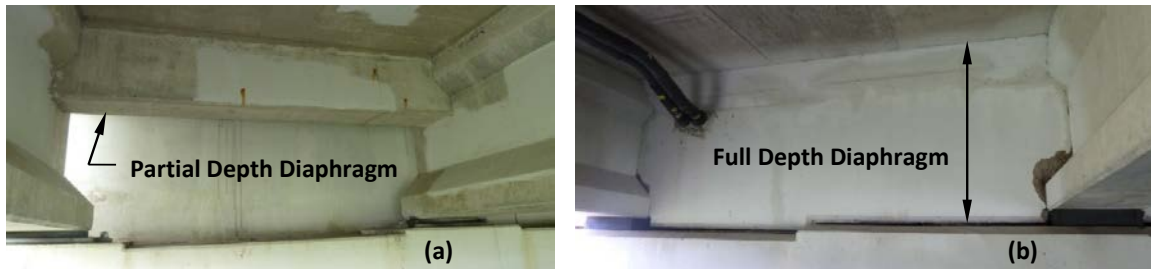
Figure 6.1: (a) Partial depth and (b) full depth diaphragm with interface cracking

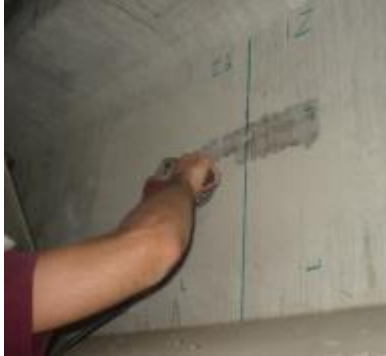
3. Clean prepared surface with acetone, rag, and dry with a can of compressed air.	----

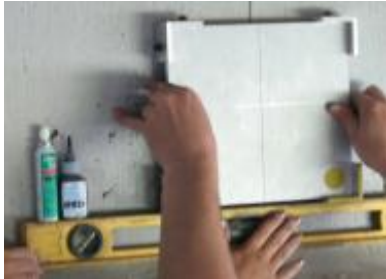
5. Carefully remove blank aluminum plate from lower corner mounts. Apply strain relief aluminum angle to the right or left of the lower corner mount with same epoxy/accelerant method.

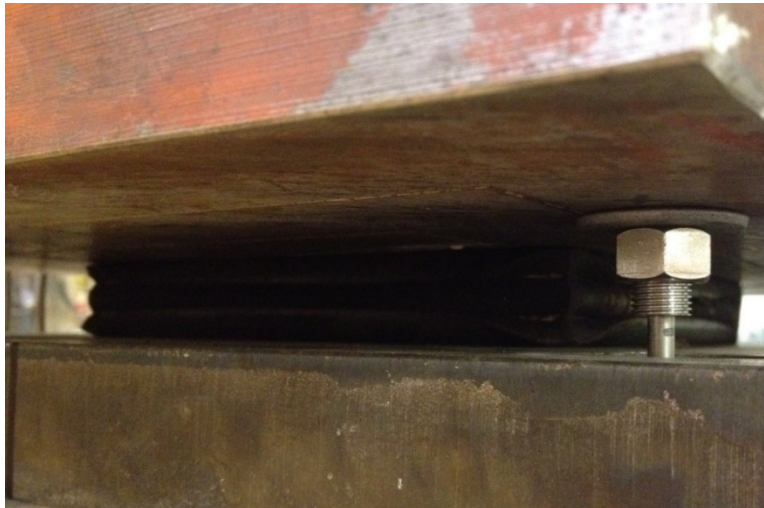
Figure E.11: Bulging observed in 1-3/8 in. bearing pad

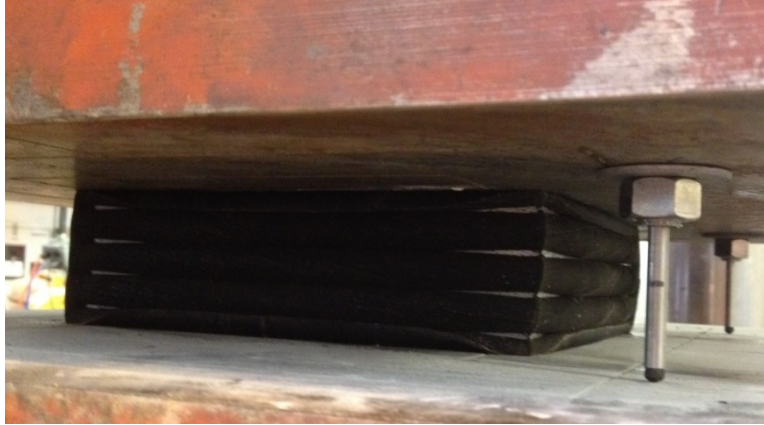
Figure E.14: Bulging observed in 2-1/2 in. bearing pad

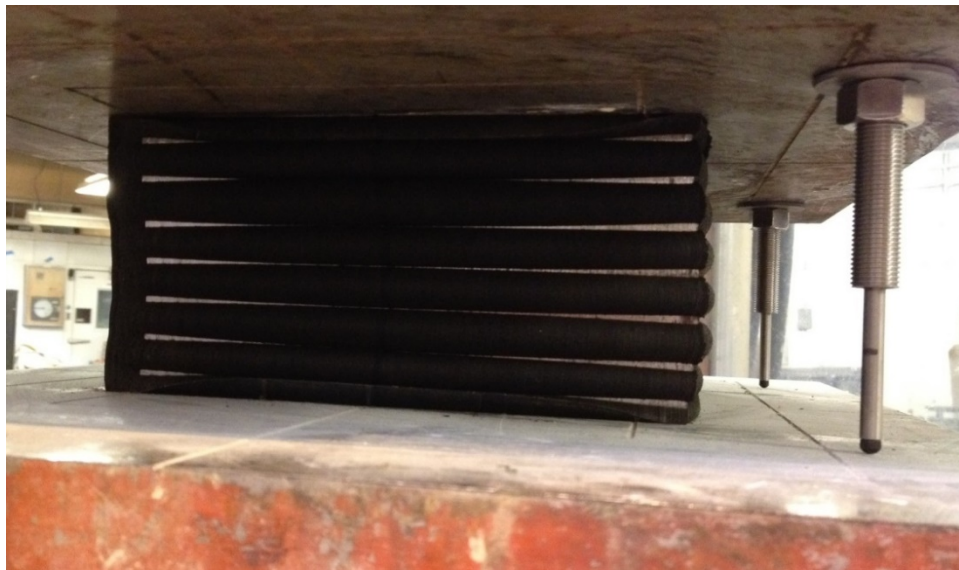
Figure E.17: Bulging observed in 4-3/8 in. bearing pad

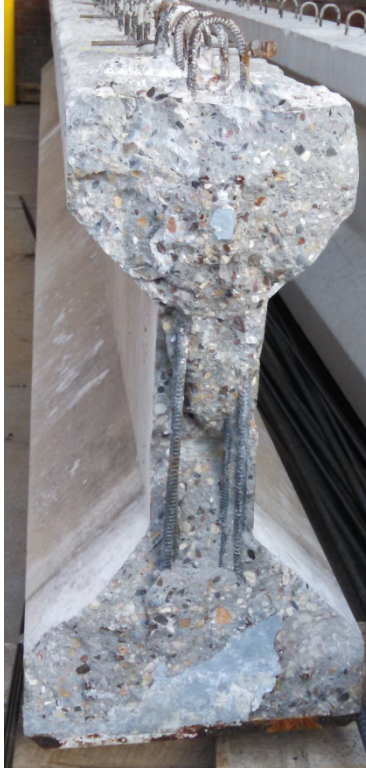
Figure F.3: Damaged end of Bridge 62834 girder (exposed stirrups)

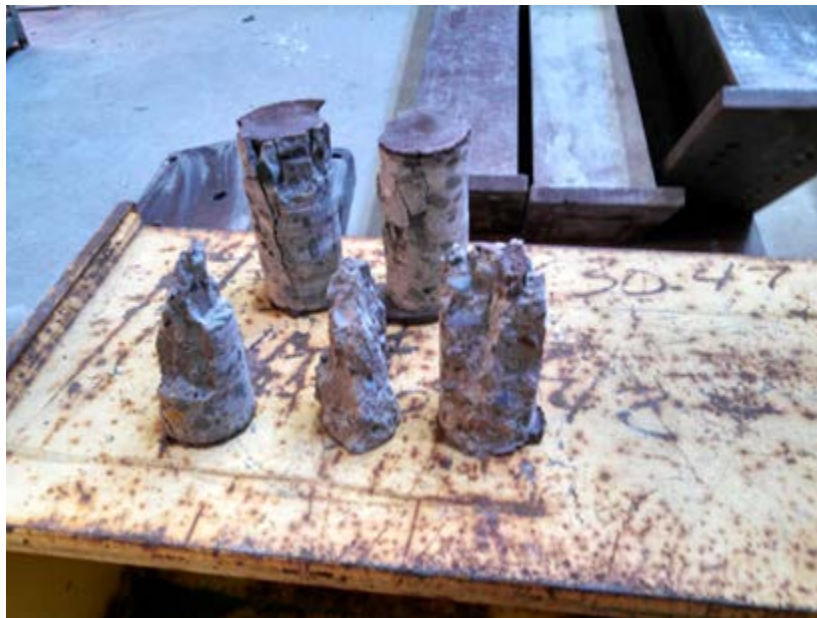
Figure F.4: Failed core samples from Bridges 27799L and 62834

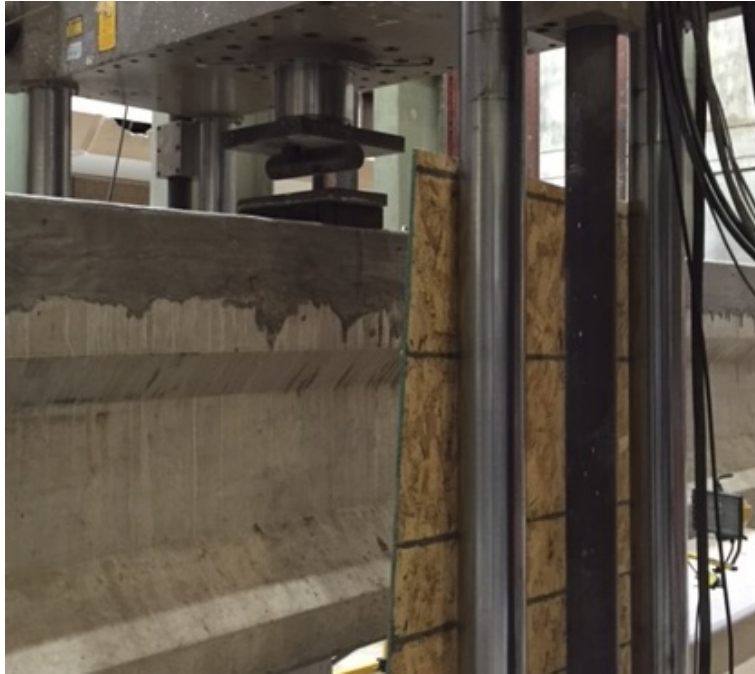
Figure F.5: Typical point load boundary conditions

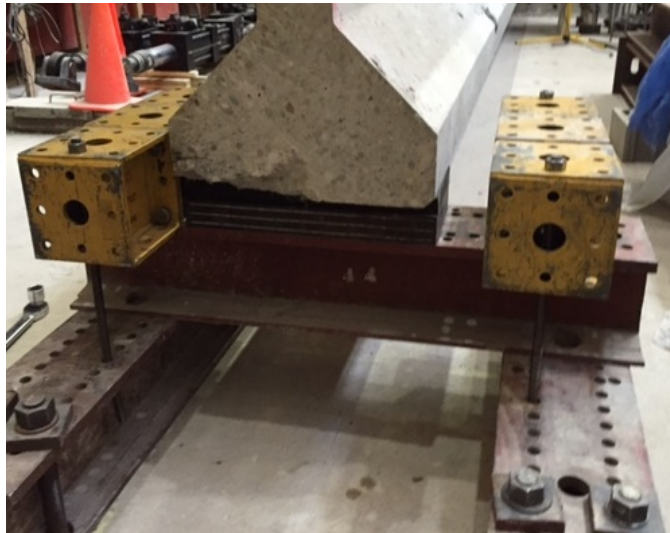
Figure F.6: Typical girder support boundary conditions

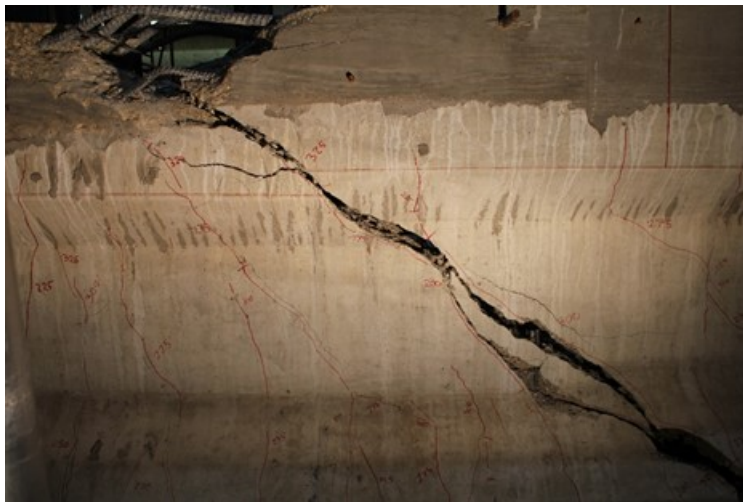
Figure F.8: Photograph of Bridge 27799L girder at end of test showing first observed shear crack, which occurred near applied load in long shear span (labeled “200” kips)

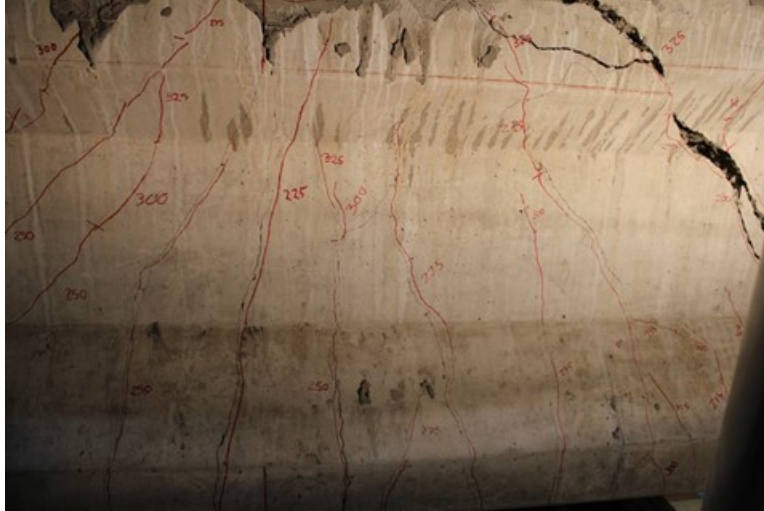
Figure F.9: Photograph of Bridge 27799L girder at end of test showing flexural cracks observed below the applied load

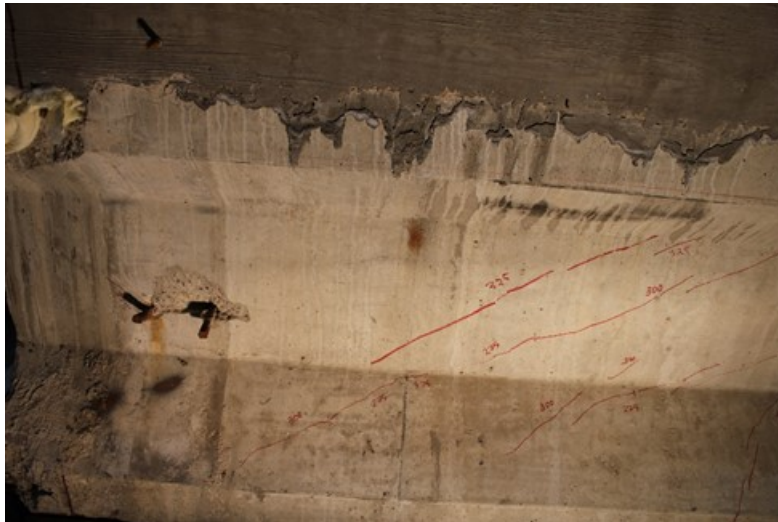
Figure F.10: Photograph of Bridge 27799L girder at end of test showing first shear cracks observed near support in short shear span

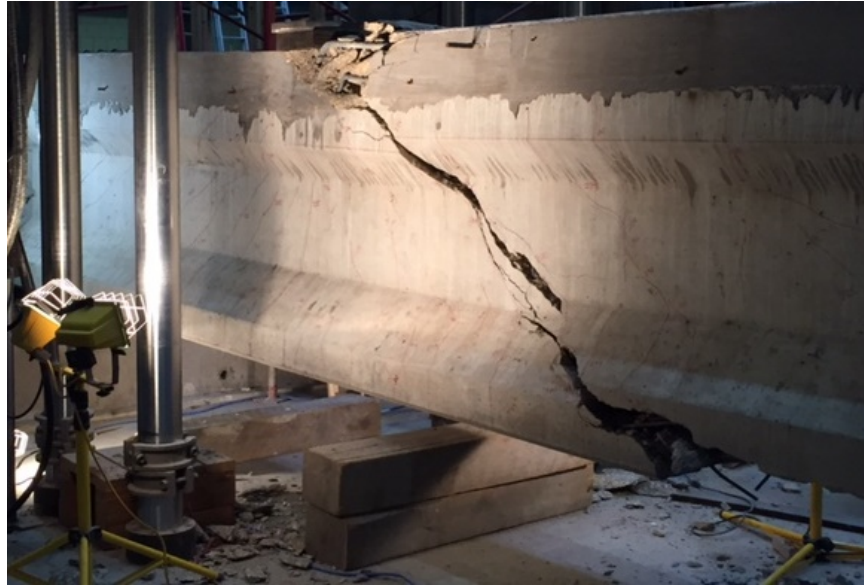
Figure F.11: Failure of Bridge 27799L girder in flexure-shear

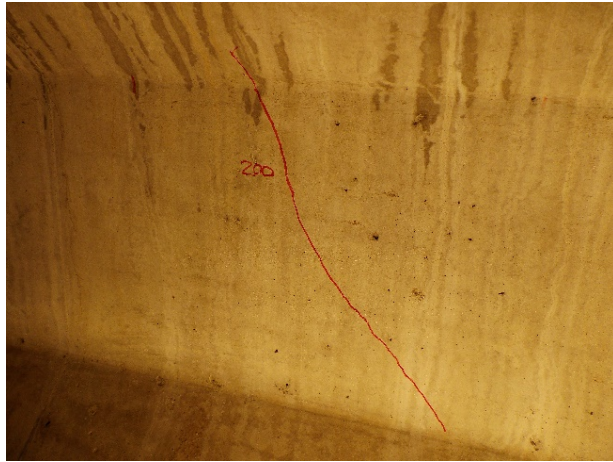
Figure F.12: Photographs of observed crack progression in Bridge 27799L (a) first cracking (web-shear crack in long shear span visible at 200 k); (b) cracking in same region at load of 325 k; (c) after failure

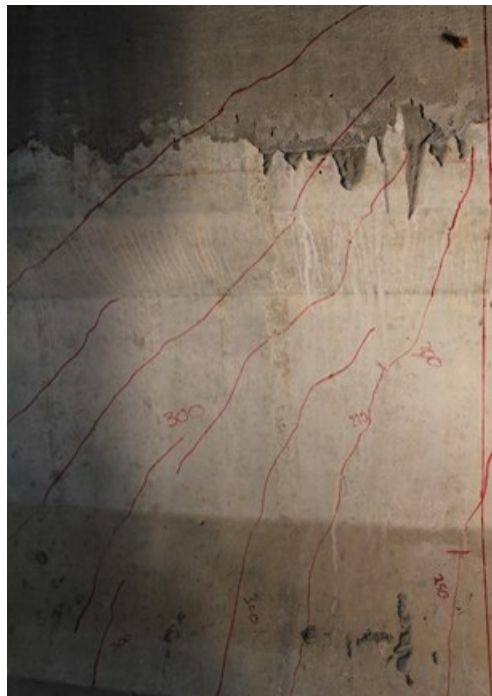
Figure F.14: Photograph of Bridge 62834 girder (End A) at end of test showing flexural cracks observed below applied load

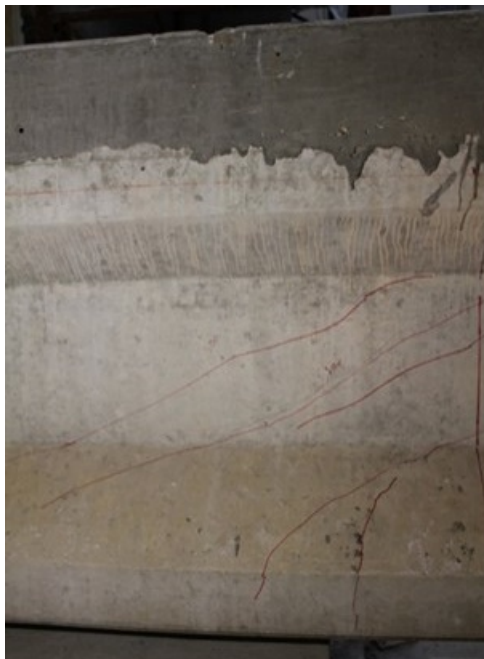
Figure F.16: Photograph of Bridge 62384 girder (End A) at end of test showing first shear cracks observed near support in short shear span

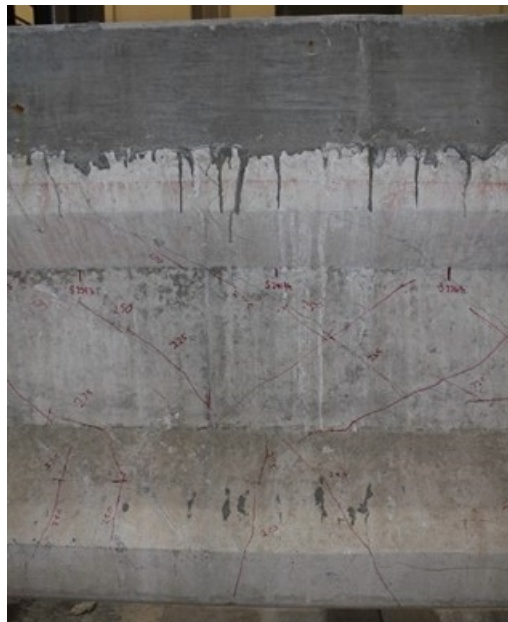
Figure F.18: Photograph of Bridge 62384 girder (End B) at end of test showing first observed shear cracks, which occurred near applied load in long shear span

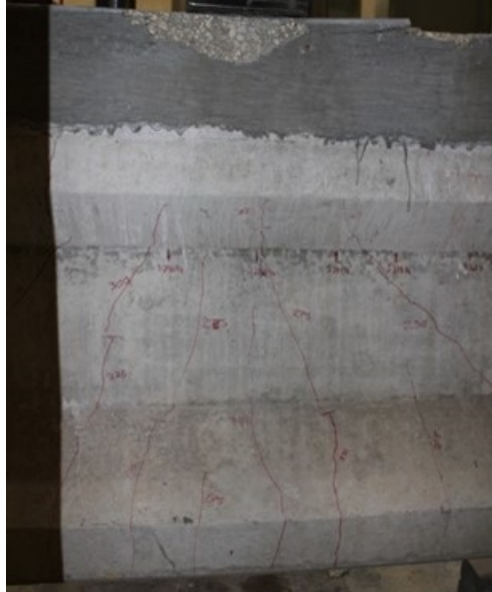
Figure F.19: Photograph of Bridge 62384 girder (End B) at end of test showing flexural cracks observed below applied load

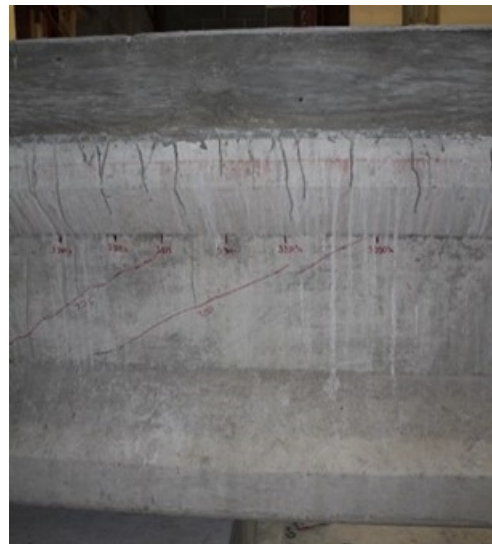
Figure F.20: Photograph of Bridge 62384 girder (End B) at end of test showing first shear cracks observed near support in short shear span

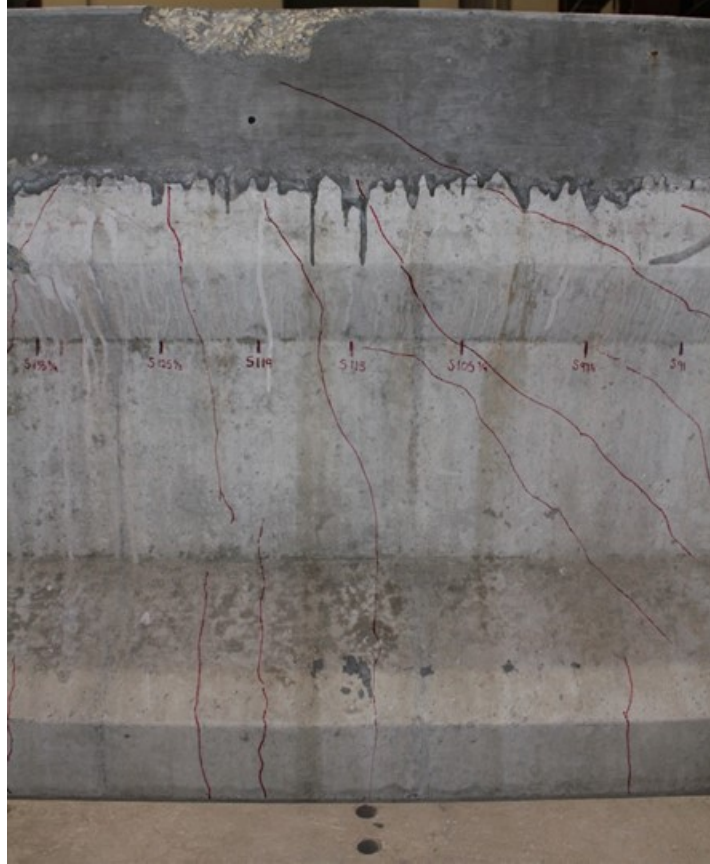
Figure F.21: Photograph of Bridge 62384 girder (End B) at onset of deck concrete crushing
