# Matrix (Partially Grouted) Riprap Lab Flume Study

Minnesota  
Department of  
Transportation

Jeffrey D. G. Marr, Principal Investigator  
St. Anthony Falls Laboratory  
University of Minnesota

Research Project  
Final Report 2015-15

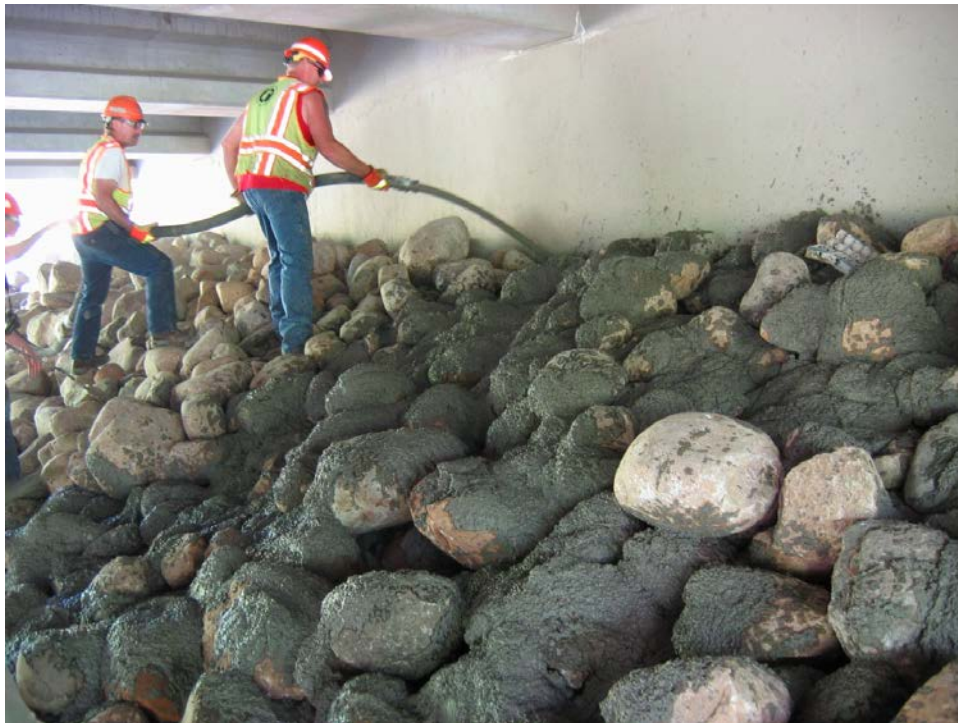
**Figure 3.1 -Grout application at Bridge No. 48030, Milaca, MN**

Figures 3.1 and 3.2 are photographs showing the placement of the grout during the installation. The flow rate of the grout pump did present some issues with the accuracy of grout placement. Typically the grout is pumped onto the stone within inches of the stone surface, but the high flow rate required the person applying the grout to stand back several feet, which resulted in grout splashing over the surface of the stone. The finished surfaces at this installation are not ideal. Please see more representative images in Appendix B.

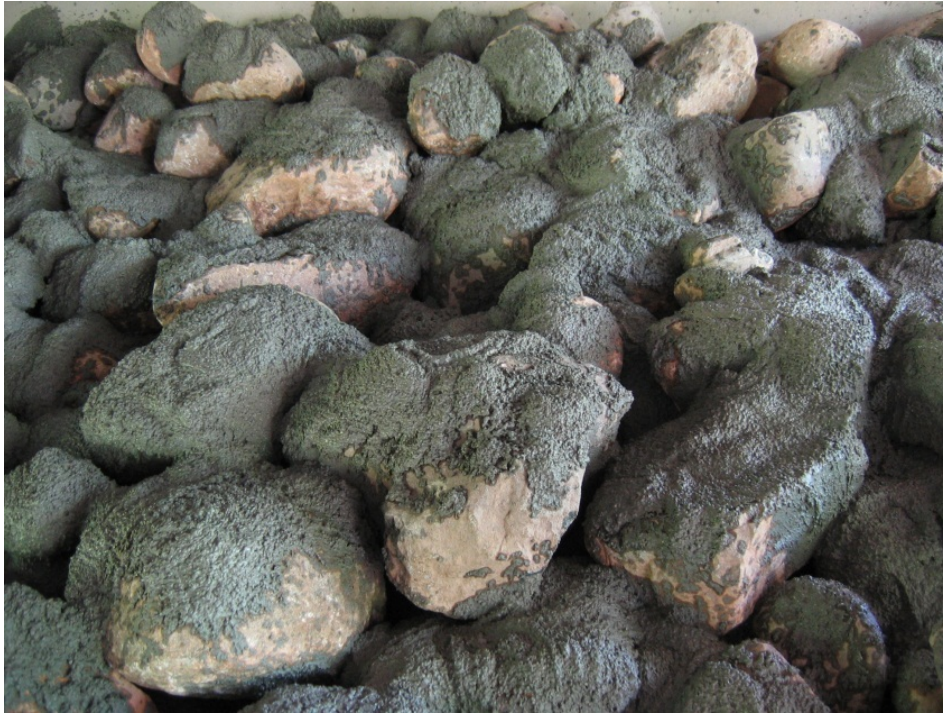
**Figure 3.2 - Matrix riprap at Bridge No. 48030, Milaca, MN**

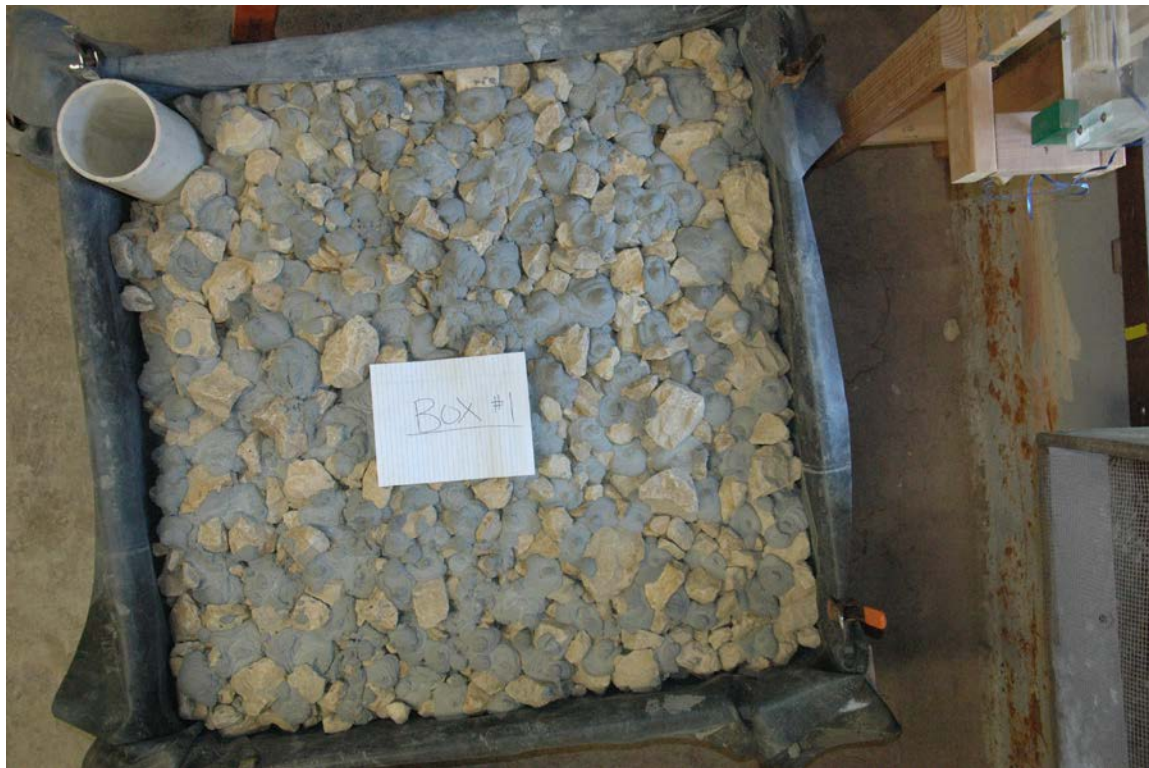
Figure 4.1. Example Out-of-Flume test box configuration.

Class I and Class II limestone rock riprap obtained from a local quarry was investigated in this phase. The size and gradation of the stones met the MnDOT standard definition for Class I or Class II riprap. The riprap material was hand-placed into the testing box with depths equivalent to several  $D_{50}$  diameters. For the Class I riprap the stone was placed at a depth of 9 inches and for the Class II riprap stone was placed at a depth of 12 inches.

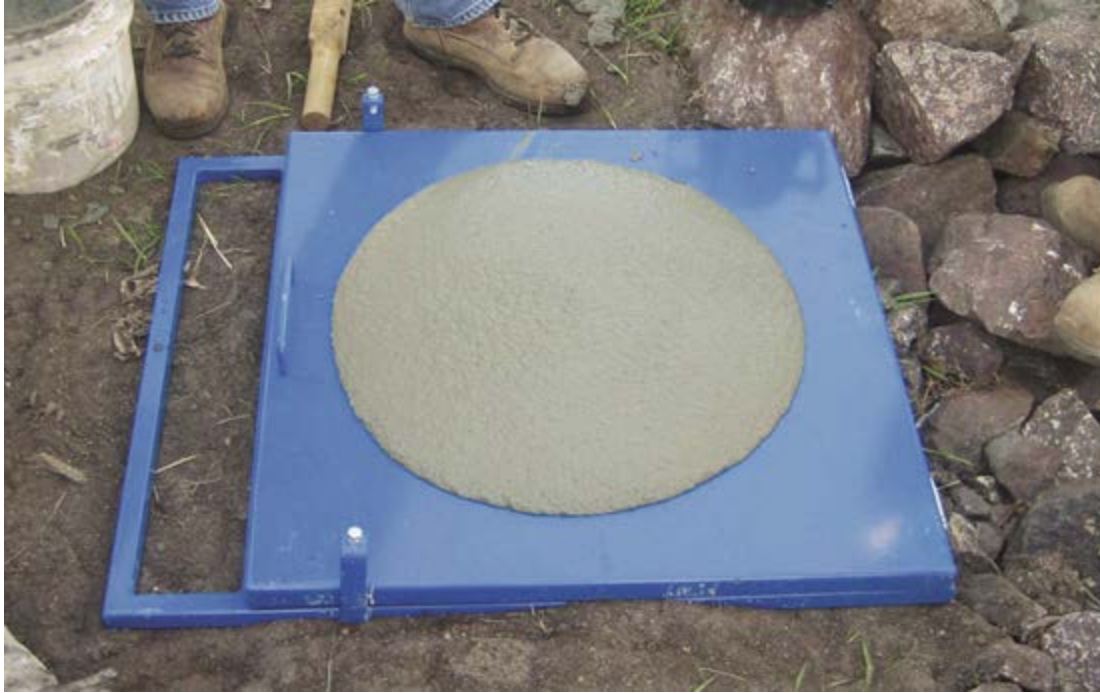
**Figure 4.2. Image of slump cone and table apparatus.**

- 13.4 to 15 inches (34 to 38 cm) diameter, no tapping of the table
- 19.7 to 21.25 inches (50 to 54 cm) diameter, 15 taps of the table

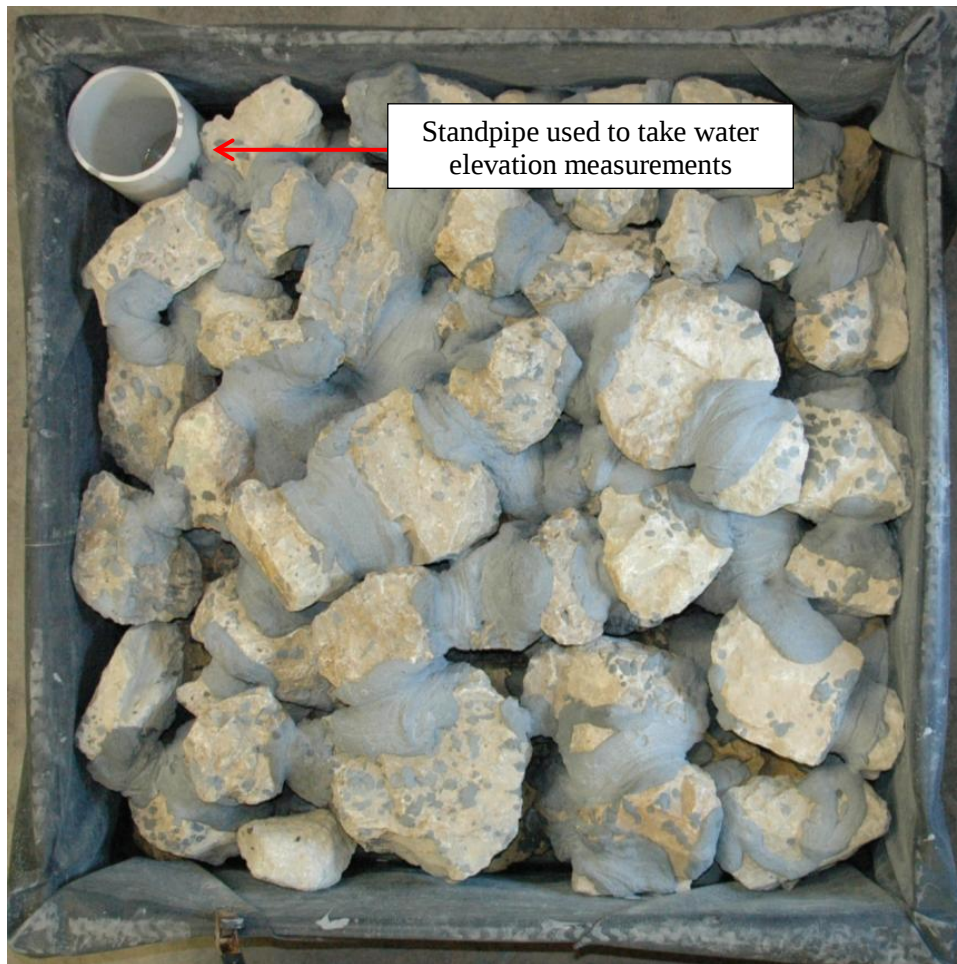
**Figure 4.3. Image of a box after filled with riprap and grouted.**

Grout was applied to each test patch using a technique similar to what would be performed in the field. Grout mixture was loaded into a five gallon hopper and the hopper was lifted above the testing basins to “pressurize” the flow. A 1.5-inch (3.8 cm) diameter hose was attached to the bottom of the hopper, with a nozzle at the end of the hose. The nozzle was held by the “installer” during application. The hopper was suspended approximately 4 feet above the test patches by a ceiling mounted trolley. Grout was applied to all contact points. Grout was allowed to cure for a minimum of 24 hours prior to the water tests and for a minimum of 6 weeks prior to mechanical pull testing. Figure 4.3 is an image showing the finished matrix riprap surface from a Class II test.

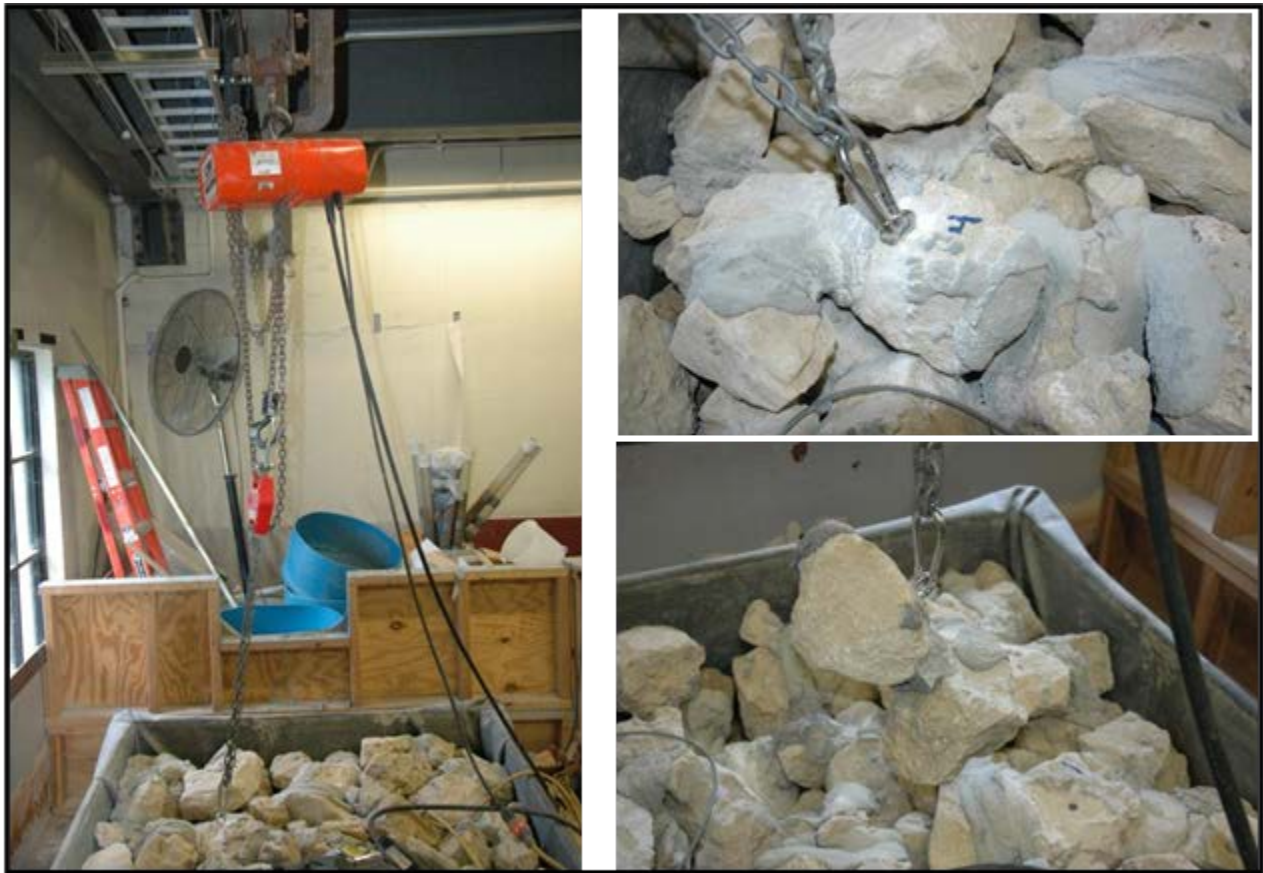
Figure 4.13. Mechanical pull test apparatus and anchoring system.

The test patches were loaded using a 0.5-ton capacity electric hoist, steel chain and cable, and a 430 lb capacity digital pull scale (Figure 4.13). When possible, the steel cable was wrapped around the stone. If it was not possible to wrap the cable around the stone, the cable was attached to an eye-bolt embedded in the stone using 0.5 inch threaded anchor. The electric hoist was used to apply a load on the rock and a digital pull scale displayed the load weight on the stone. The stones were loaded until either they failed or until the maximum load was reached for the scale/hoist.

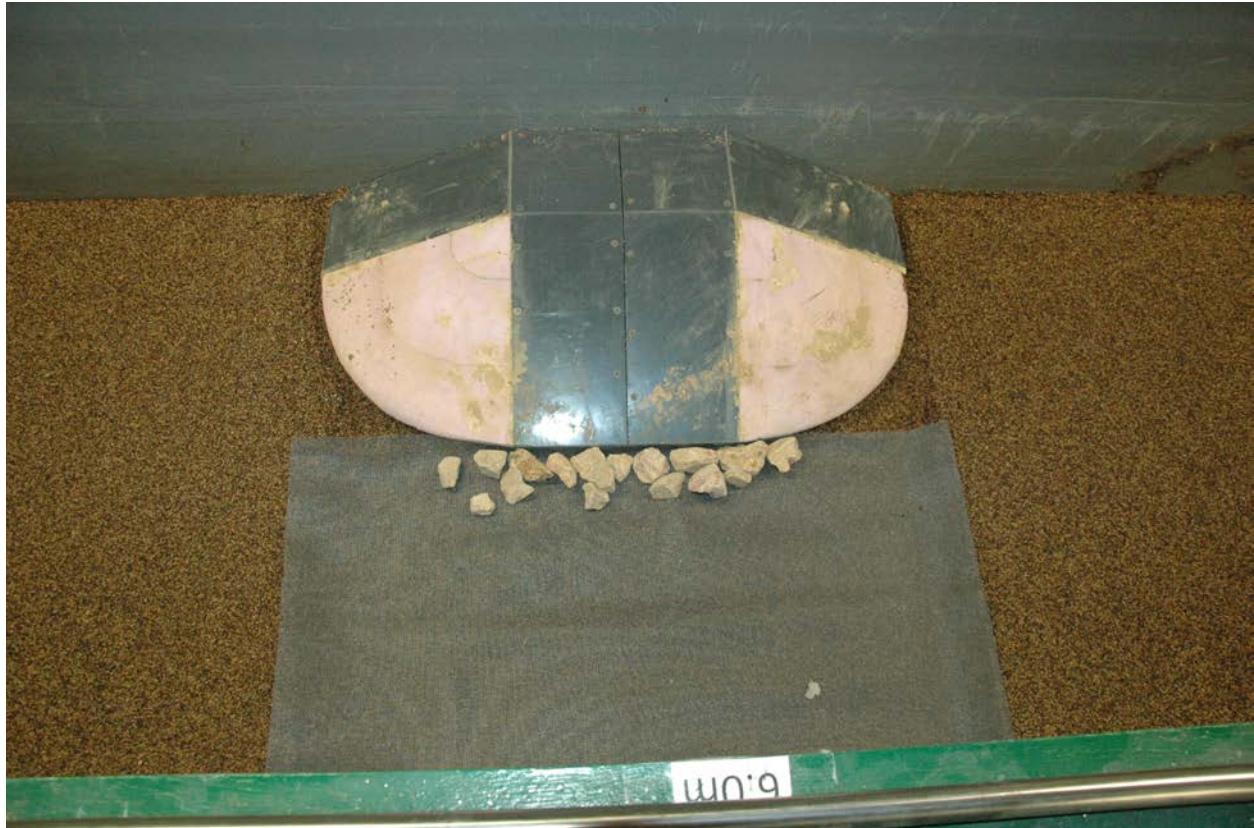
**Figure 5.4.** Image showing the setup for a spill through abutment experiment in the Tilting Bed Flume. The image shows the filter material, the model riprap material, and Model 1 Abutment.

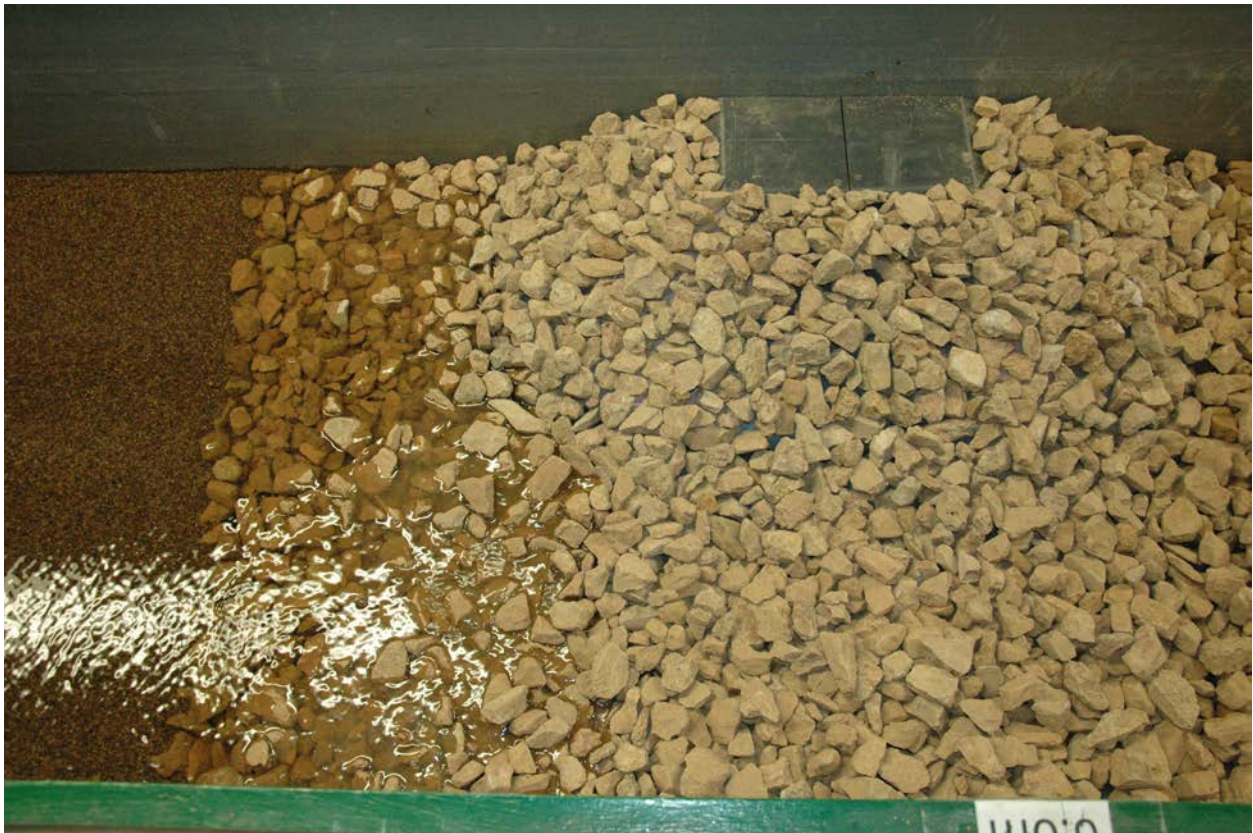
**Figure 5.6. Photograph of the abutment with 25 mm riprap material.**

Series A focused on flow through a single spill-through abutment protected by a 1-inch riprap material and was placed in a conventional manner, i.e. no matrix material. The Model 1 abutment configuration was used, which as an abutment width (transverse to flow) of 18-inches.

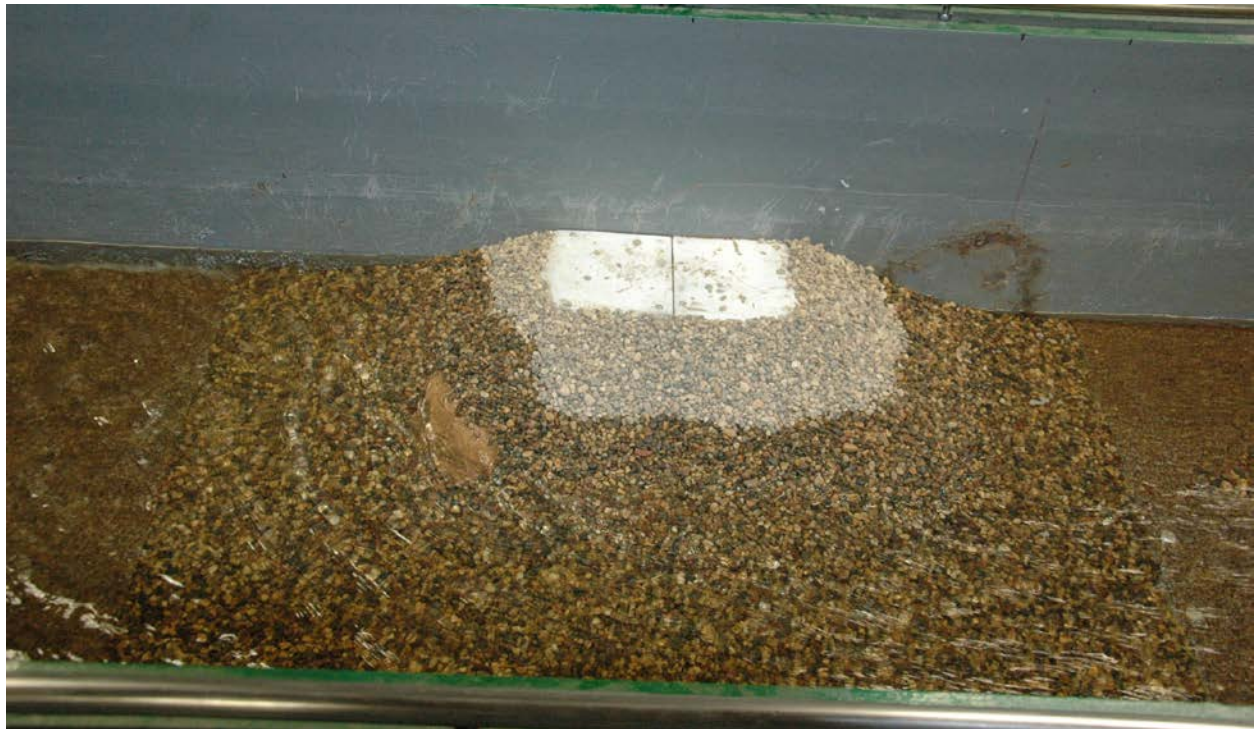
**Figure 5.12. Flume setup for Model 1 with pea gravel.**

Because of high velocities required to get the 1-inch conventional riprap to fail, the research team switched to a 0.2-inch pea gravel. The flume was set to zero slope and 1.7 mm sand was placed upstream and downstream of the riprap in the same way as described for Series A. Flow rates of 5.6, 6.8, 7.8, 8.7, 11 and 20 L/s were evaluated. It was determined that to move the pea gravel, a flow rate higher than 11 L/s was required. Figure 5.9 shows the flume setup for the initial runs, and Figure 5.10 shows the movement of the pea gravel between the 11 L/s flow rate and the 20 L/s flow rate.

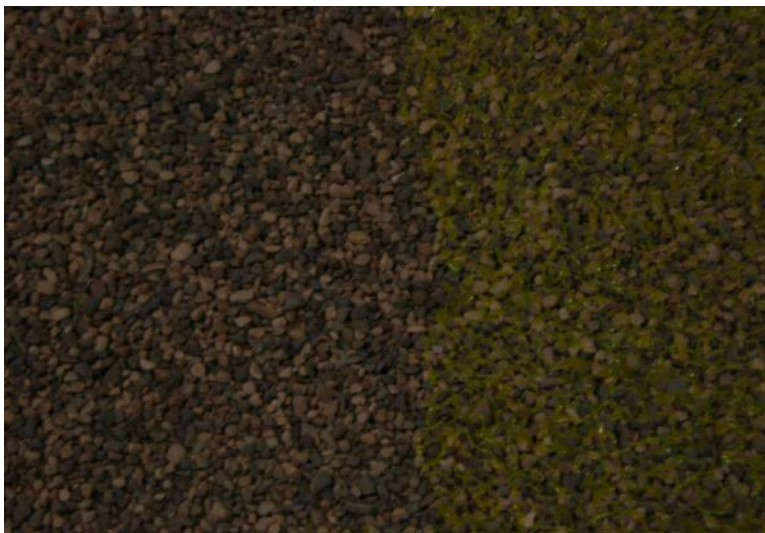
**Figure 5.16. Side by side comparison of pea gravel surface with and without hot glue "grout".**

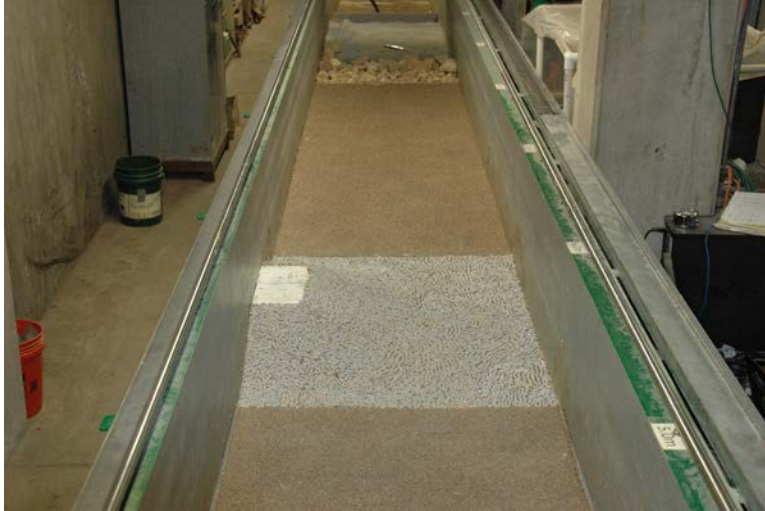
**Figure 5.18. Image of Quickcrete matrix riprap within the Tilting Bed Flume.**

In a second trial, a quickcrete compound was used as the grout material and was applied in the same manner as the hot glue (Figure 5.18). Flows were tested up to 45 L/s and at slopes 1.5%, 2% and 3% without failure of the matrix riprap material. At this point, the flow began to overtop the spill through abutment and the experimental conditions became unrealistic. It was therefore concluded that it was not possible to reach the failure point of the matrix riprap within the Tilting Bed Facility under the Model 1 or Model 2 test setup.

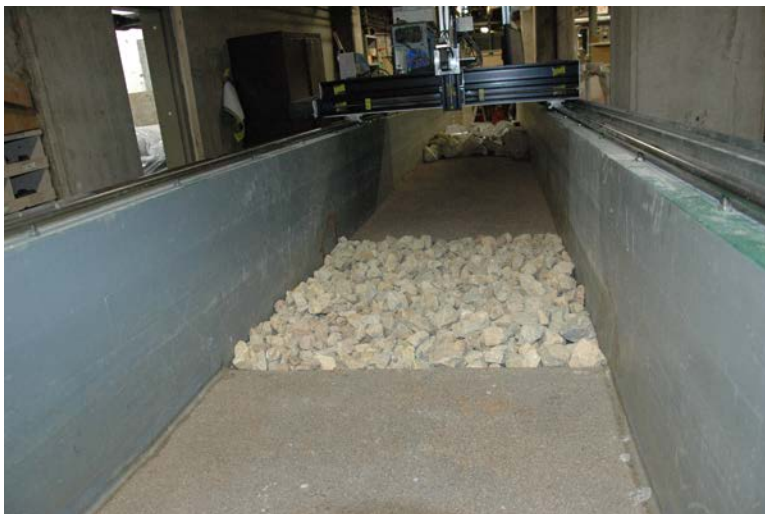
**Figure 5.19. Plane bed configuration, riprap only.**

Series D moved away from testing under a spill-through abutment configuration and focused on examining the failure point of conventional and matrix riprap under a plane bed condition. The goal of the series was to observe and document the failure point of matrix riprap. Figures 5.19 and 5.20 show the layout of the plane bed configuration. Testing was conducted in the Tilting Bed Flume at 1% slope and used a Class I riprap material with a  $D_{50}$  of 1.9 inches. The larger rock was used in this testing to allow use of the design grout rather than a surrogate material. Using the plane bed configuration, the tests were able to fail the Class I riprap (Figure 5.21). However even at the maximum flow and slope condition in the flume, it was not possible to fail the matrix riprap (Figure 5.22). The conclusion of this series is that the flume was not capable of failing the material and no longer useful for the overall project.

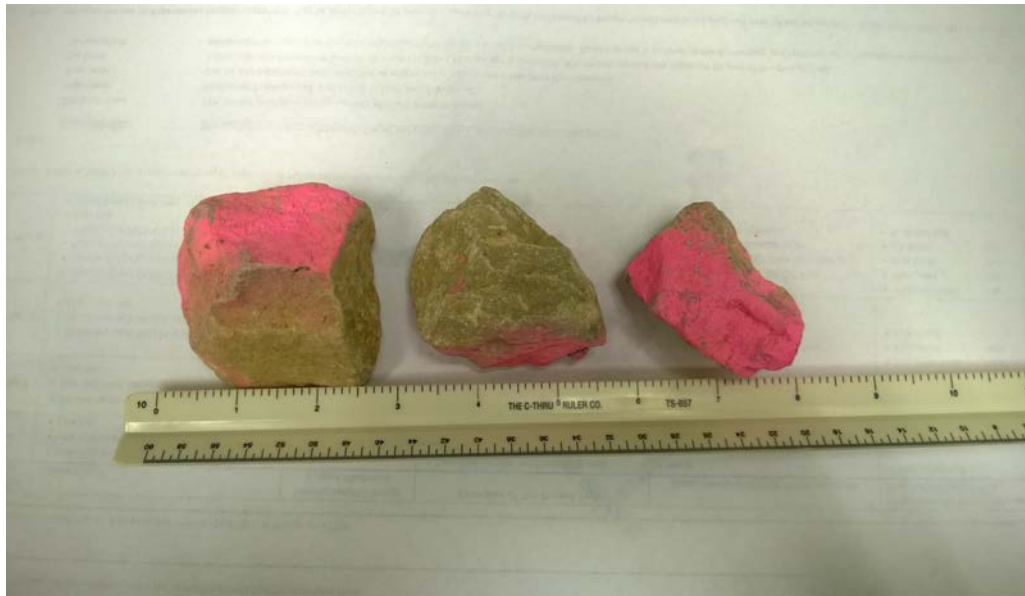
**Figure 6.2. 2-inch angular gravel.**

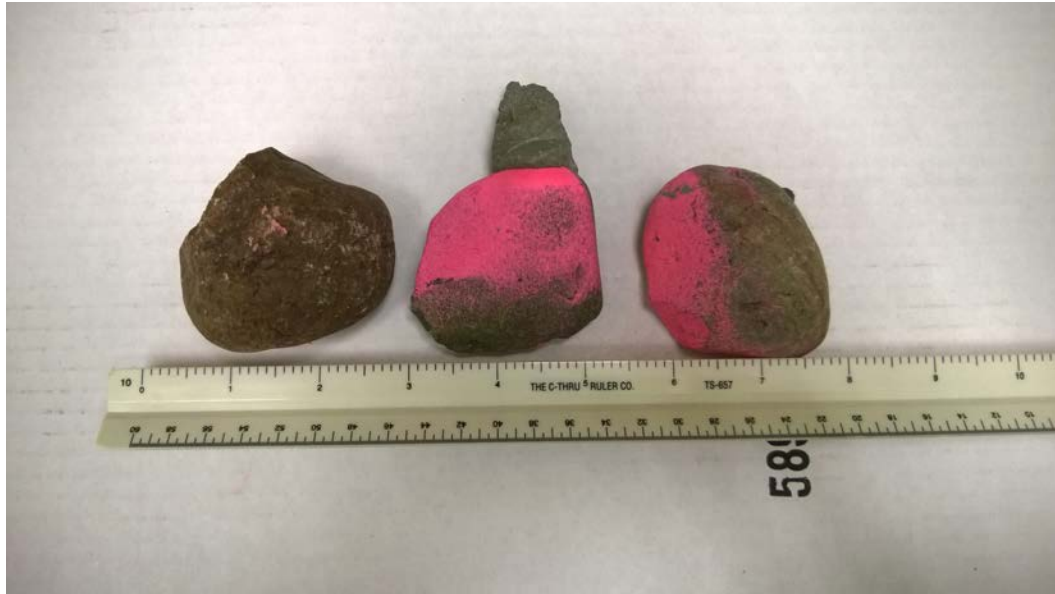
Figure 6.3. 2-inch river rock.

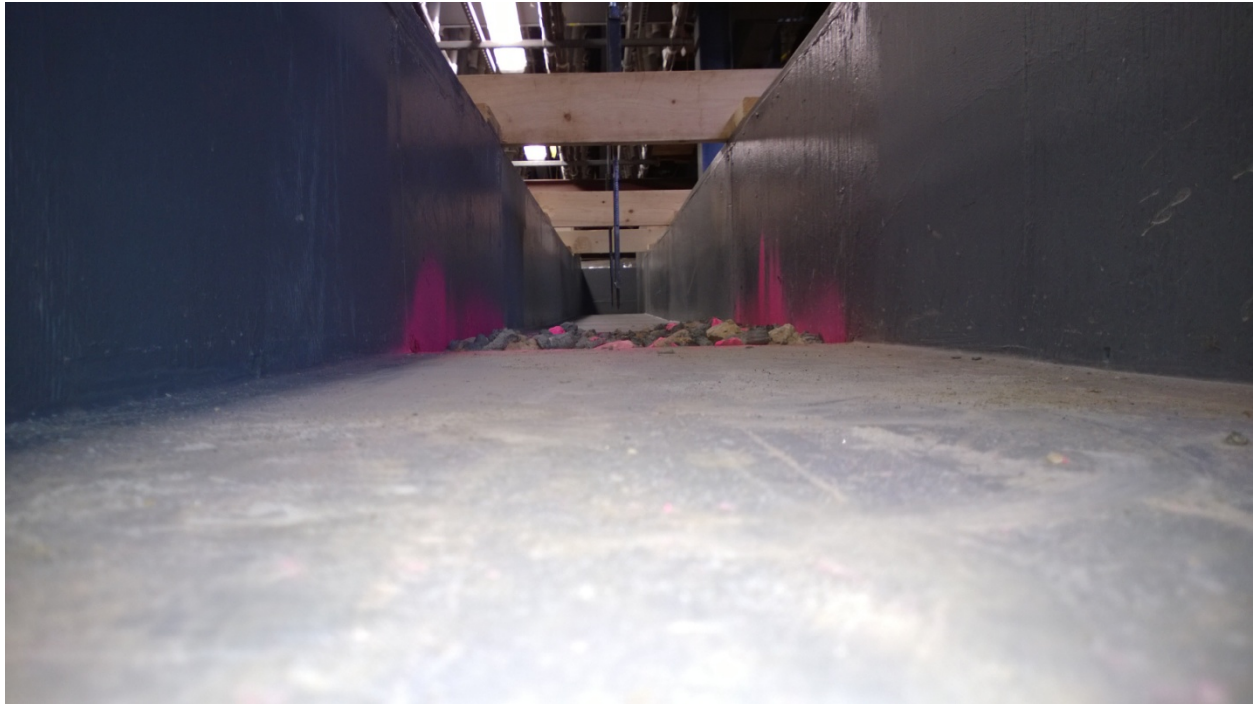
**Figure 6.4. Flume floor from downstream to upstream.**

It was observed in the initial runs that the actual elevation of the riprap was important in flow testing. Initially, the upper most elevation of the riprap was higher than the bed surface by approximately  $D/2$ , where  $D$  is the diameter of the rock. This resulted in unrealistic hydraulics caused by impact of water on the leading edge of rock and resulting in a large “rooster tail” effect. After making this observation, the rocks were placed such that the top of the rock was approximately at the elevation of the bed. Figure 6.4 is a photo taken from the bottom of the flume looking upstream and showing very few rocks were higher than the bed of the flume.

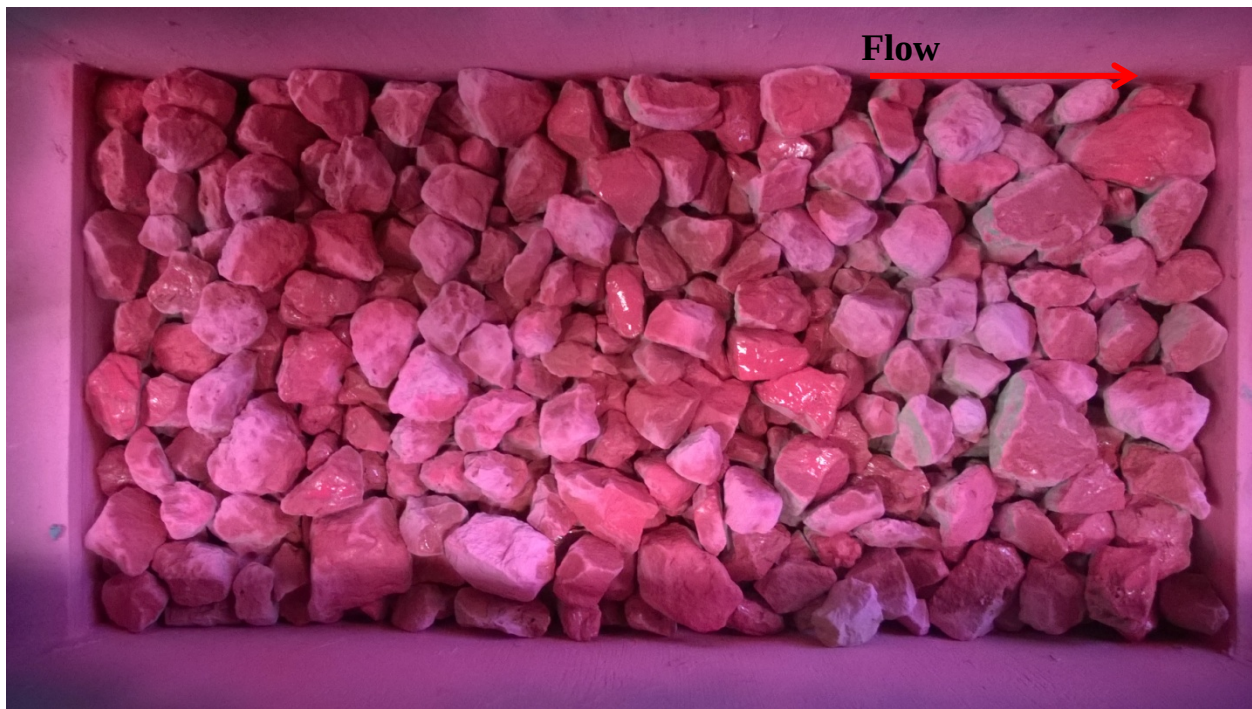
**Figure 6.8. Pre-Run 1, 2-inch angular gravel with no grout.**

The 2-inch angular gravel was run with no grout and a maximum flow rate of 0.2 cfs. Failure was noted at a velocity of approximately 6.7 fps and a bed shear stress of 0.2 lb/ft<sup>2</sup>. Figure 6.8 shows the rock placement prior to flow through the flume. Figure 6.9 shows the rock alignment after the 0.2 cfs flow was completed, with the area of movement highlighted.

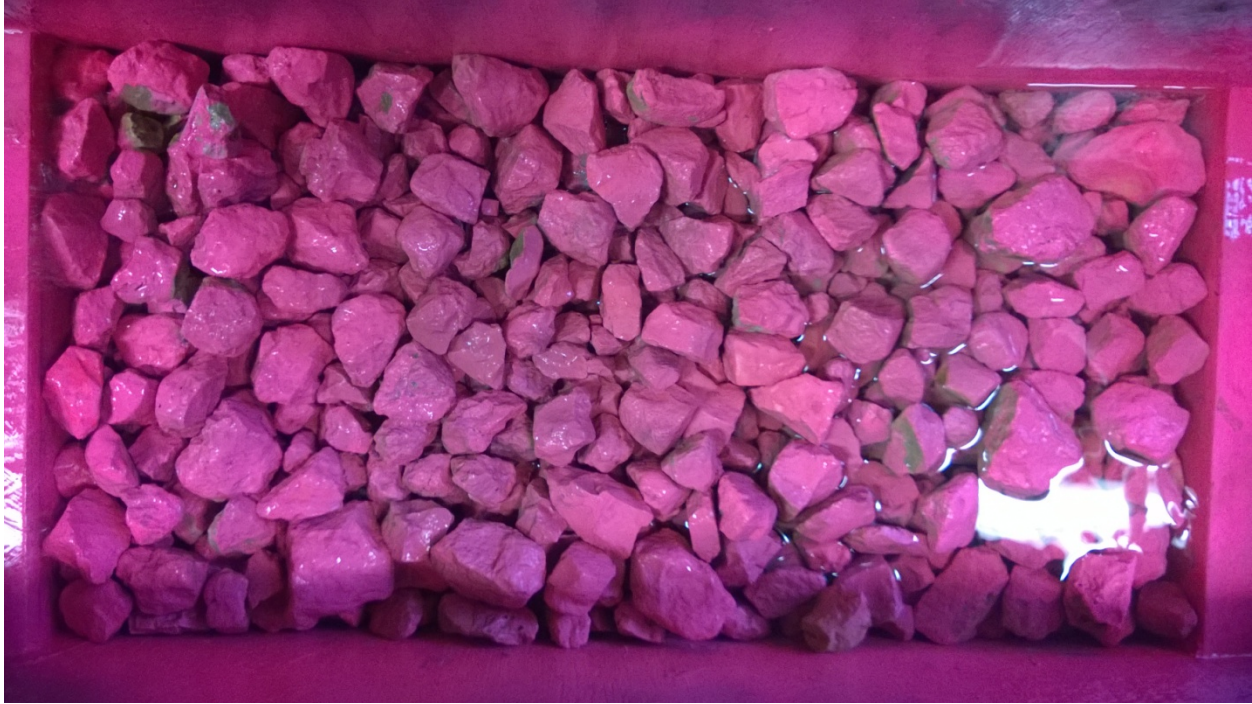
**Figure 6.9. Post-Run 1, 2-inch angular gravel with no grout.**

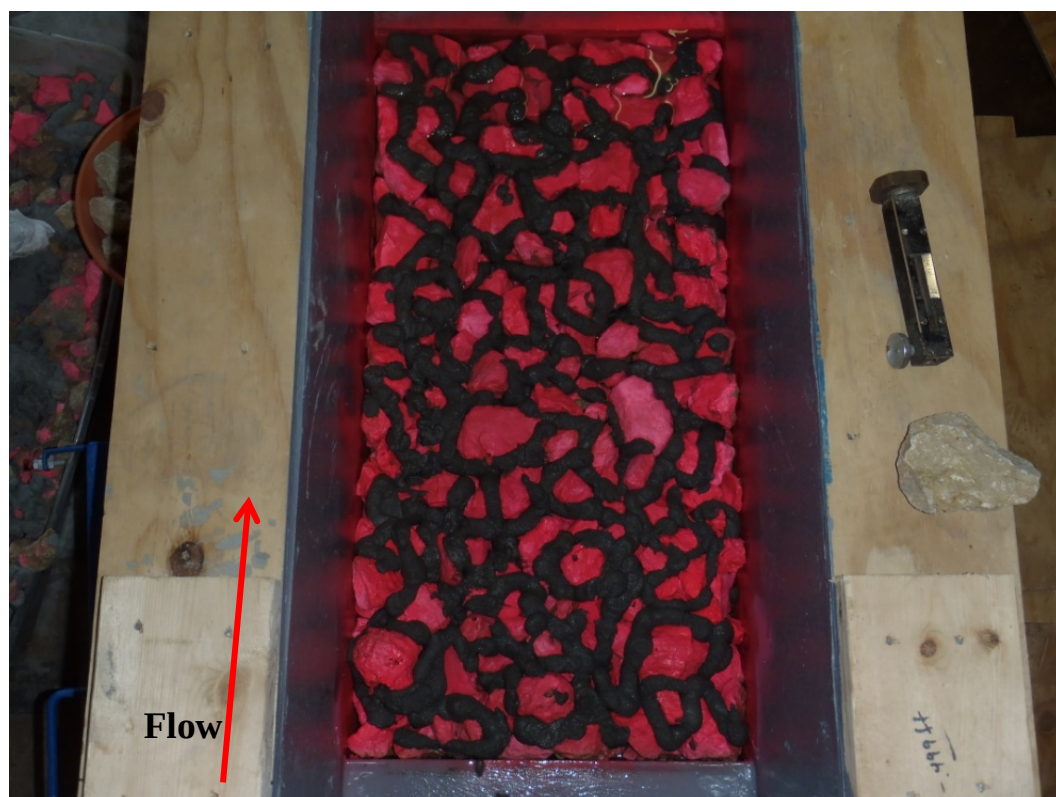
Figure 6.11. Post-Run 2, 2-inch angular gravel with grout placed according to MnDOT guidelines.

Two runs were completed using the 2-inch angular gravel with grout placed according to MnDOT recommended guidelines. Maximum flow rates of 10.4 cfs and 10.8 cfs were run through the flume, and there was no failure of the matrix riprap. These maximum flow rates correspond to velocities of approximately 15.4 and 15.7 ft/sec and shear stresses of 2.6 lb/ft<sup>2</sup> and 2.7 lb/ft<sup>2</sup>, respectively. Figures 6.10 and 6.11 show the rock for Run 2 of the original rock placement and final rock locations after the maximum flow rate was run. Figures 6.12 and 6.13 show the Run 3 original rock placement and the final rock locations. No movement of the rock can be discerned from review of the pictures.

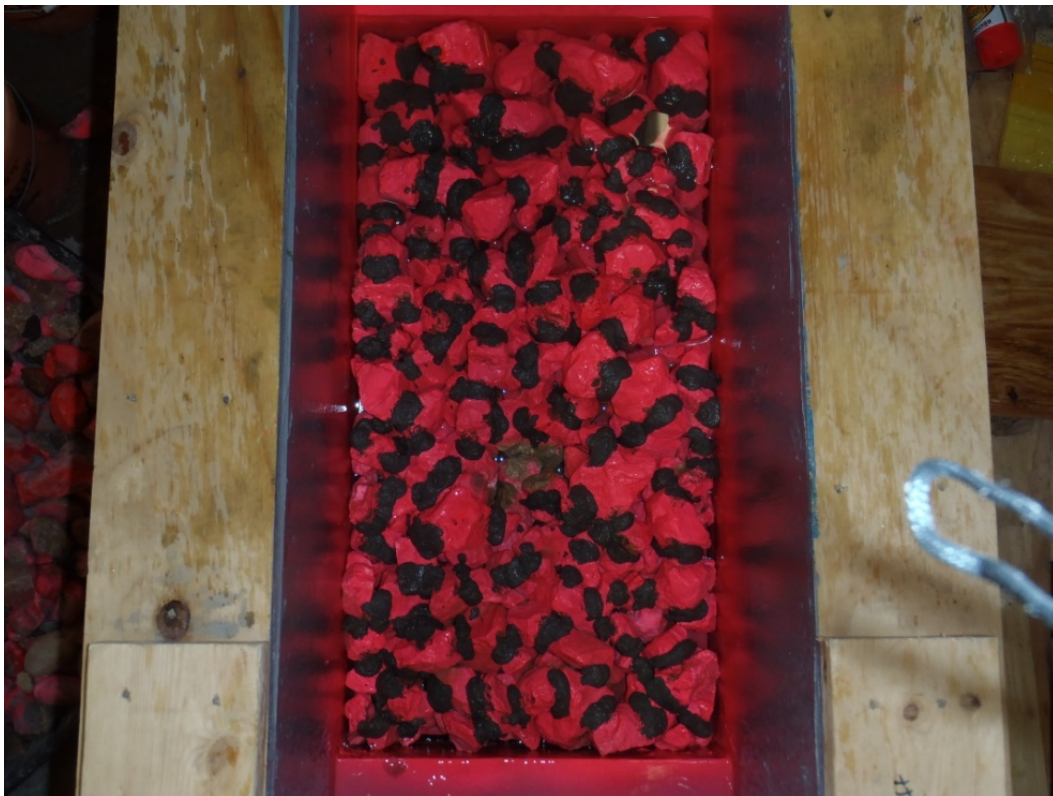
**Figure 6.15. Post-Run 4, 2-inch angular gravel with half recommended grout.**

Two runs were completed using the 2-inch angular gravel with half the recommended grout applied. Maximum flow rates of 1.5 cfs and 1.2 cfs were run through the flume, and the matrix riprap failed during both runs. Figures 6.14 and 6.15 show the original rock placement and final rock locations of Run 4, which had a maximum flow rate of 1.5 cfs and maximum velocity of 10.0 fps (bed shear stress approximately 0.8 lb/ft<sup>2</sup>). Figures 6.16 and 6.17 show the original rock placement and the final rock locations of Run 5, which had a maximum flow rate of 1.2 cfs and maximum velocity 9.0 fps (bed shear stress approximately 0.8 lb/ft<sup>2</sup>). The locations of failure are highlighted in Figure 6.15 for Run 4 and Figure 6.17 for Run 5. Failure during these runs was a result of two rocks, grouted together at one seam, shifting downstream. Failure was not a result of a fracture in the grout between the two rocks.

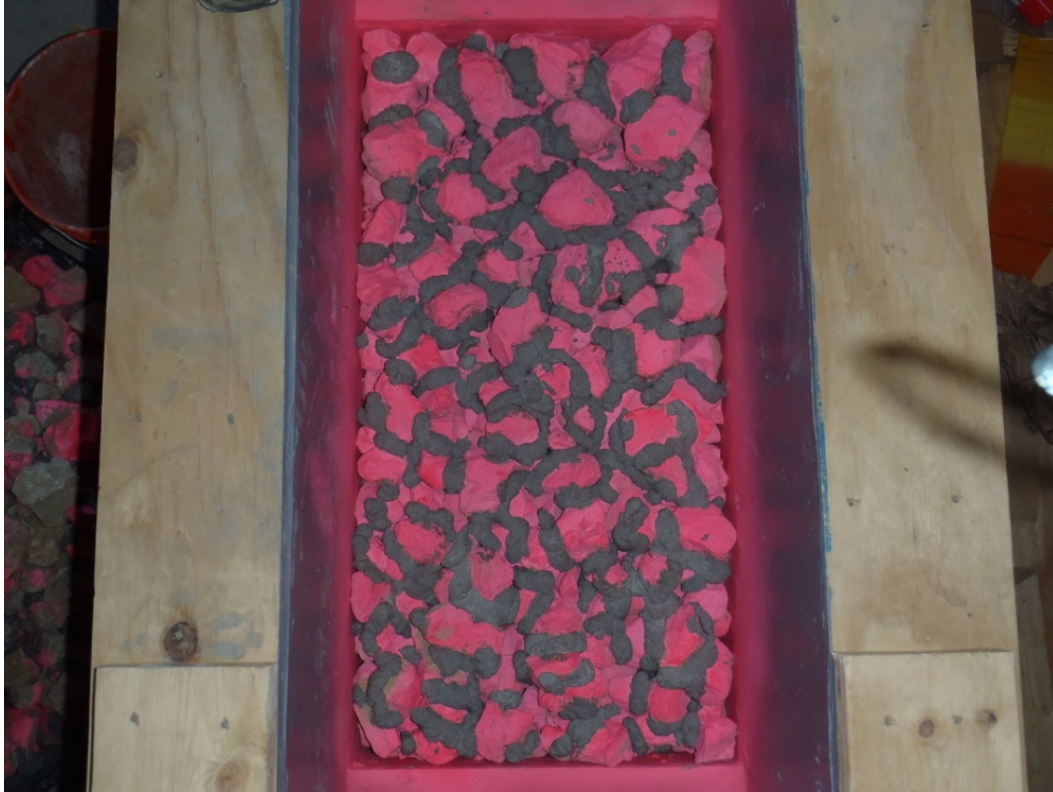
**Figure 6.16. Pre-Run 5, 2-inch angular gravel with half recommended grout.**

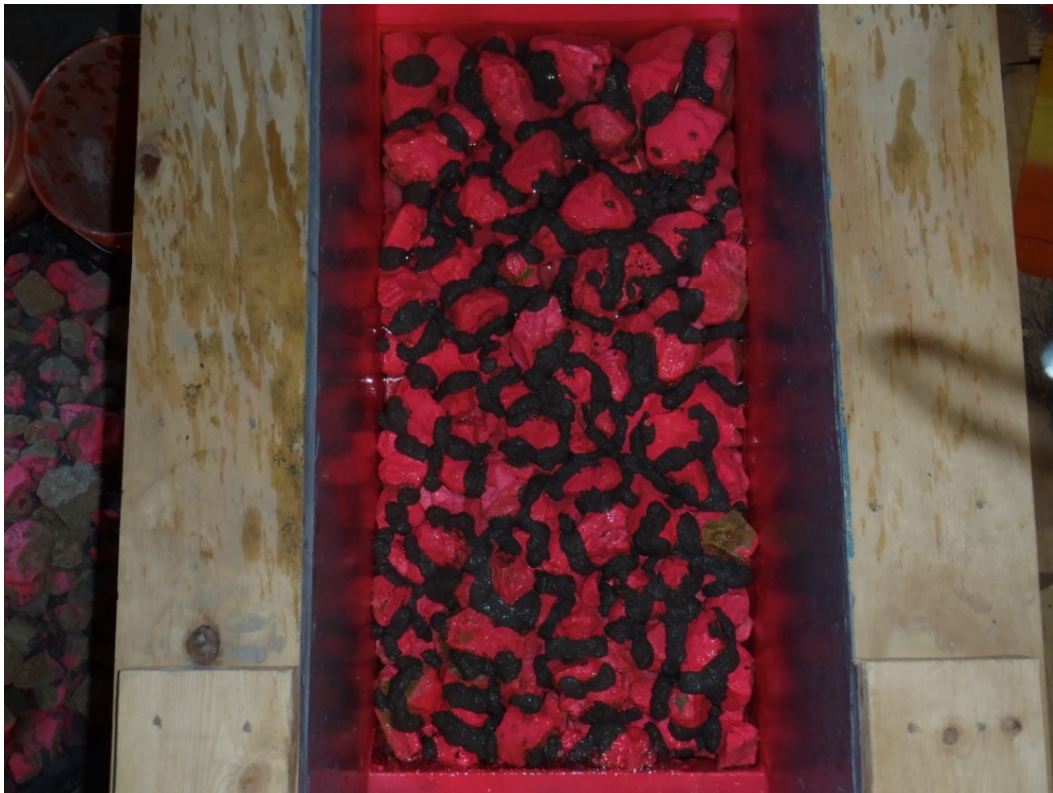
**Figure 6.17. Post-Run 5, 2-inch angular gravel with half recommended grout.**

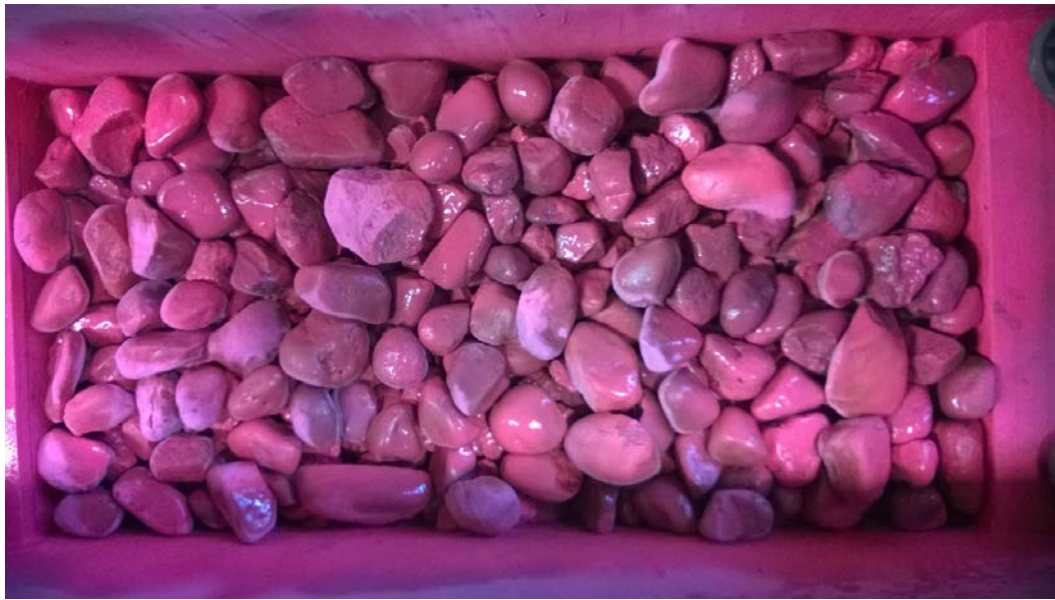
**Figure 6.18. Pre-Run 6, 2-inch river rock with no grout.**

The 2-inch river rock with no grout was run with a maximum flow rate of 0.3 cfs. Failure was noted at a velocity of approximately 6.7 fps, with a bed shear stress of  $0.3 \text{ lb/ft}^2$ . Figure 6.18 shows the rock placement prior to any flow through the flume. Figure 6.19 shows the rock alignment after the 0.3 cfs flow rate was run and the area of movement is highlighted.

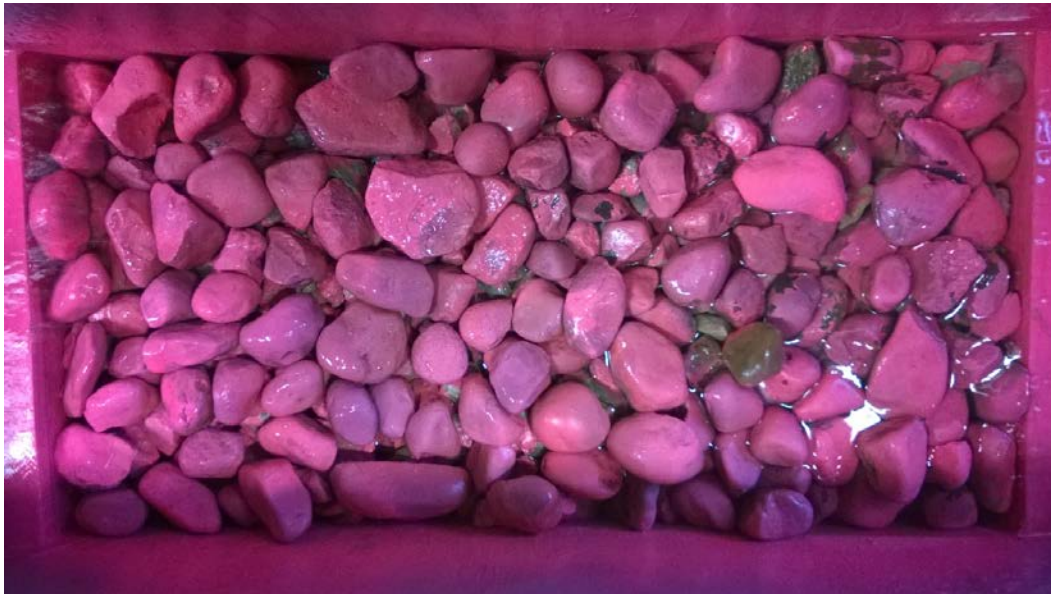
**Figure 6.19. Post-Run 6, 2-inch river rock with no grout.**

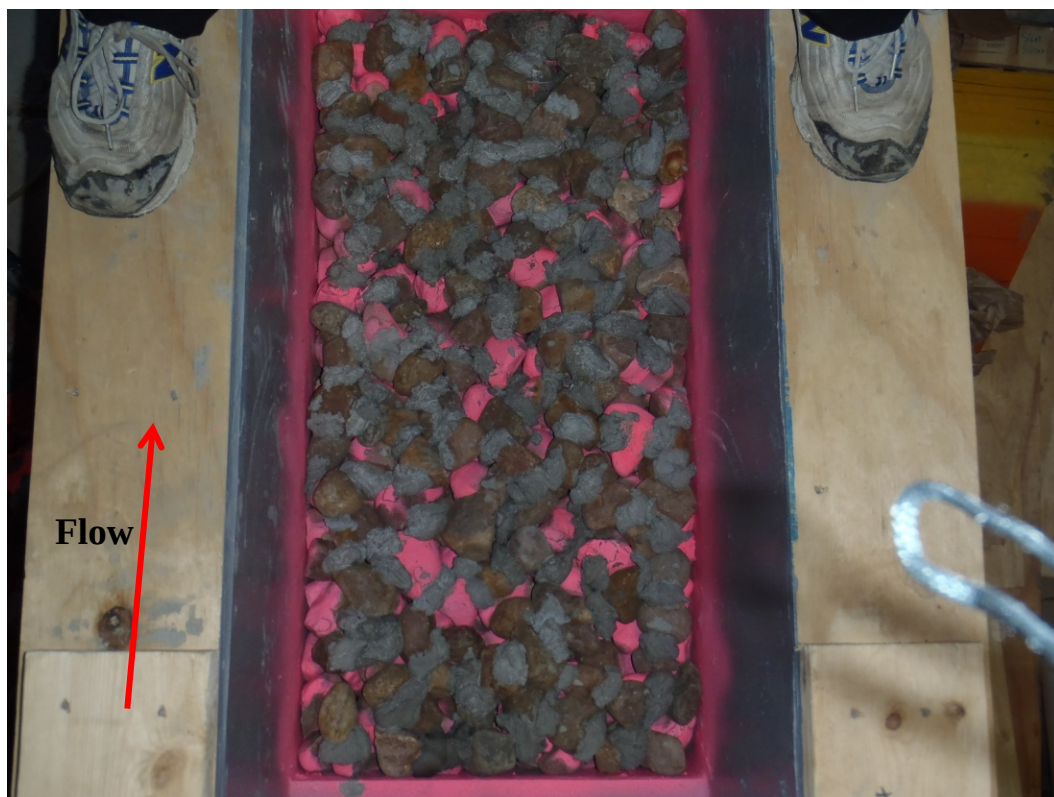
Figure 6.22. Pre-Run 8, 2-inch river rock with grout placed according to MnDOT guidelines.

Two runs were completed using the 2-inch river rock with grout placed according to MnDOT recommended guidelines. Maximum flow rates of 10.2 cfs and 10.6 cfs were run through the flume, and there was no failure of the matrix riprap. These maximum flow rates correspond to velocities of approximately 15.5 and 15.4 fps, and bed shear stresses of 2.6 lb/ft<sup>2</sup> and 2.7 lb/ft<sup>2</sup>, respectively. Figures 6.20 and 6.21 show the rock for Run 7 of the original rock placement and after the maximum flow rate was run. Figures 6.22 and 6.23 show the Run 8 original rock placement and the final rock locations. No movement of the rock can be discerned from review of the pictures.

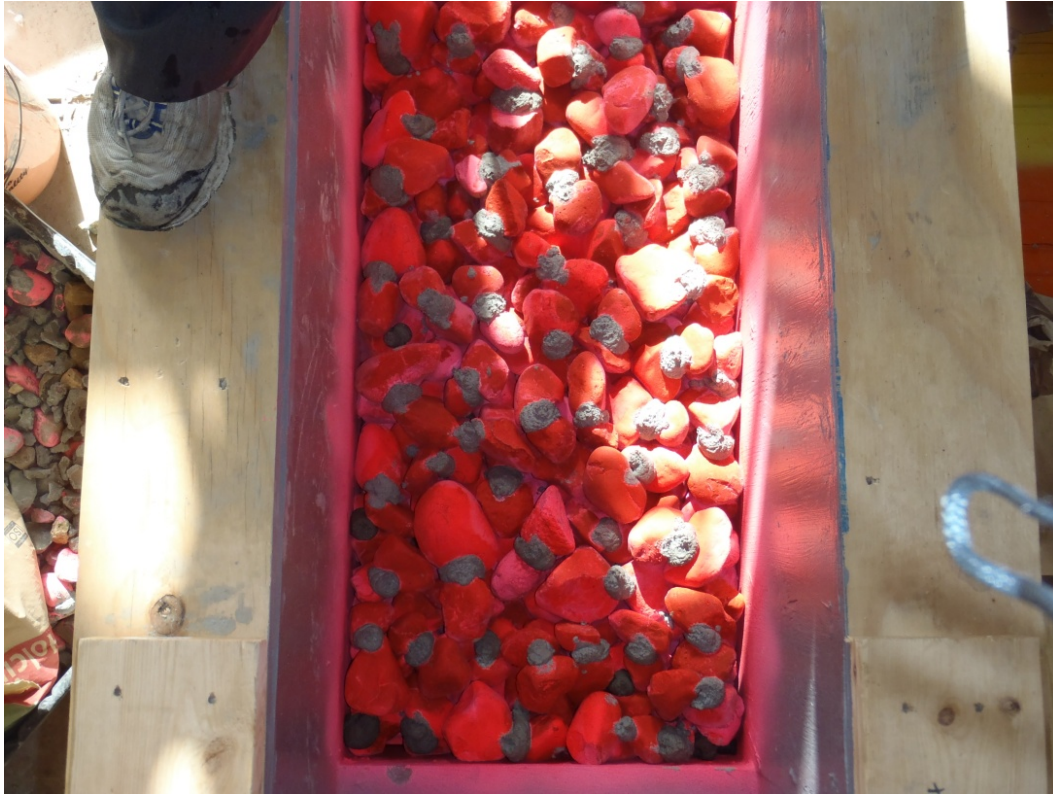
**Figure 6.24. Pre-Run 9, 2-inch river rock with half of the recommended grout.**
