# Matrix (Partially Grouted) Riprap Lab Flume Study

Minnesota  
Department of  
Transportation

Jeffrey D. G. Marr, Principal Investigator  
St. Anthony Falls Laboratory  
University of Minnesota

Research Project  
Final Report 2015-15

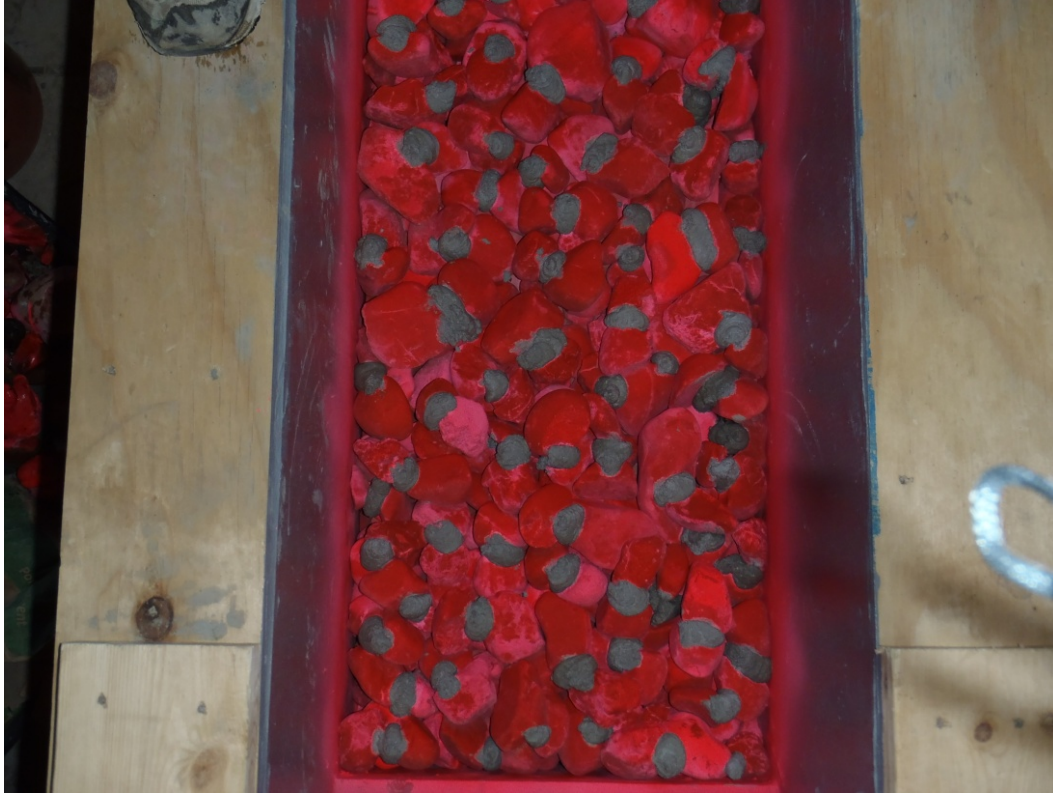
**Figure 6.25. Pre-Run 10, 2-inch river rock with half of the recommended grout.**

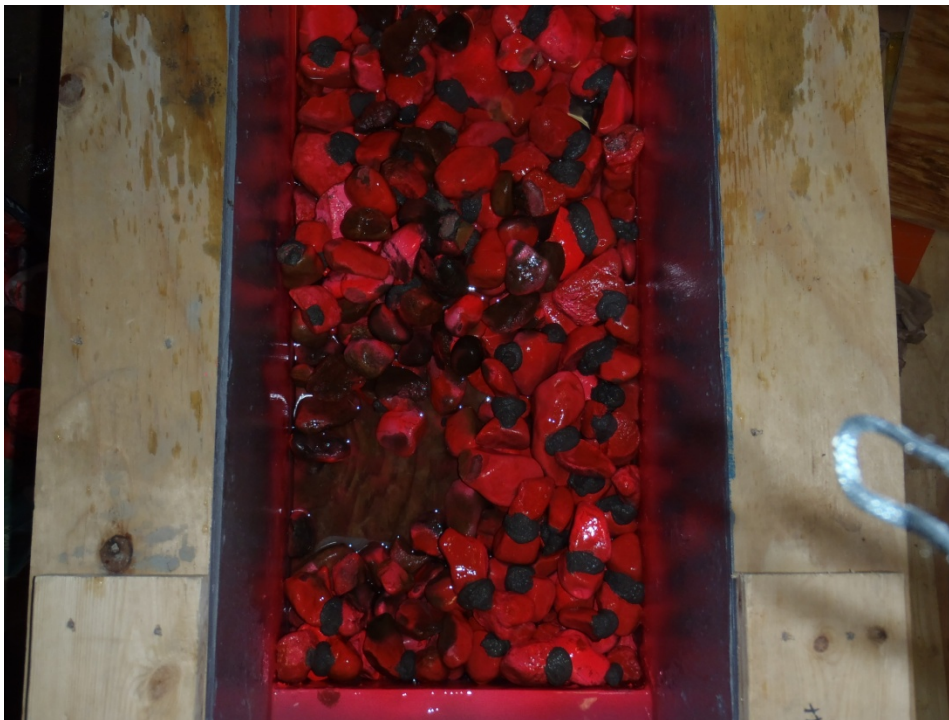
**Figure 6.26. Post-Run 10, 2-inch river rock with half of the recommended grout.**

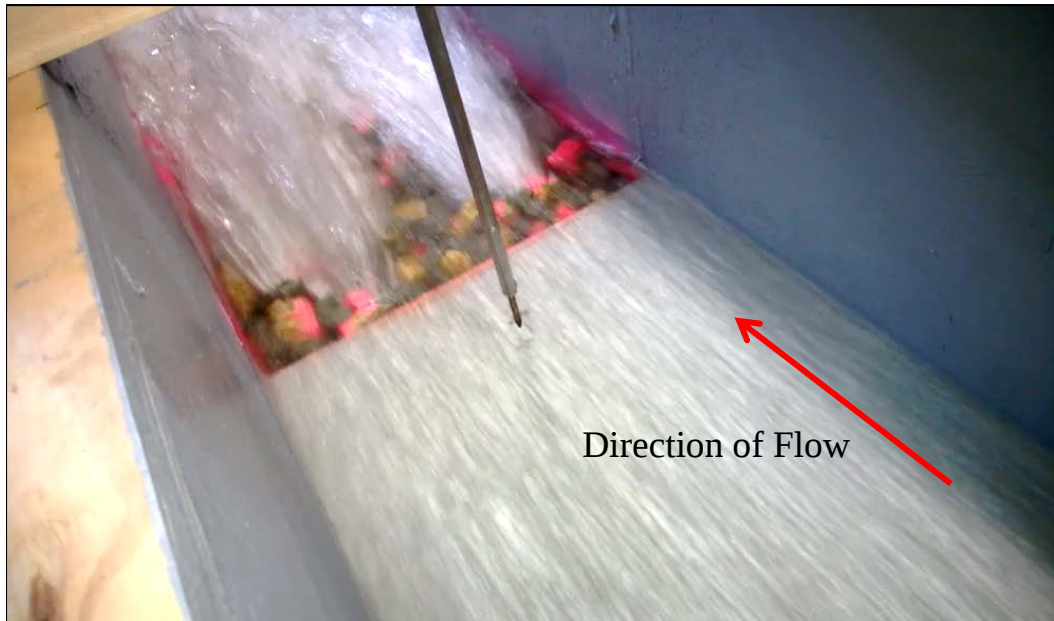
**Figure 6.27. Image of measurement location upstream of test section sump.**
