TECHNICAL SUMMARY

Pedestrian and Bicyclist Safety in Minnesota Roundabout Crossings

This Technical Summary pertains to Report 2012-28, “Investigation of Pedestrian/Bicyclist Risk in Minnesota Roundabout Crossings,” published September 2012. The full report can be accessed at <http://www.lrrb.org/PDF/201228.pdf>.

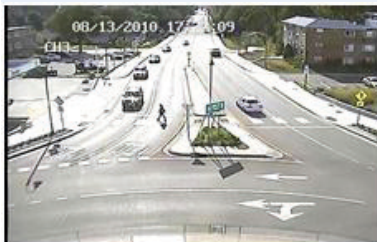
Video footage was statistically analyzed to aggregate information about pedestrian/driver interactions.

Researchers then processed and analyzed these videos to examine interactions between vehicles and pedestrians or bicyclists.

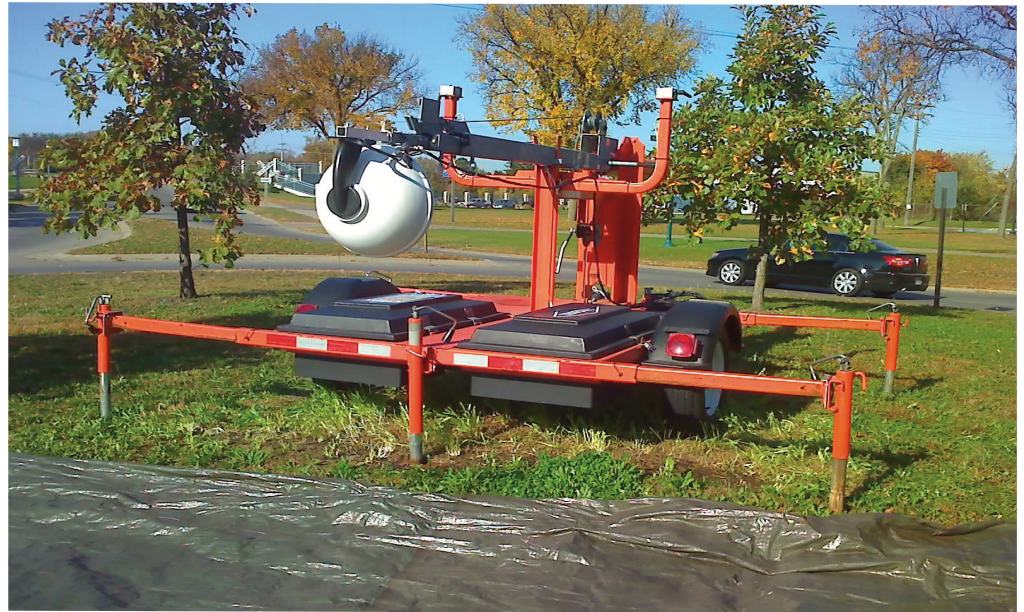
Surveillance trailers installed in the middle of roundabouts carried eight closed-circuit TV cameras and two digital video recorders to provide a clear view of the full roundabout with no blind spots.

Researchers collected information about behavior at these roundabouts through custom-made surveillance equipment that could collect seamless 360-degree video of the roundabout lanes and each of the four pedestrian crossings. This equipment recorded video at the Richfield site from August 7 to September 4, 2010, and captured 1,203 pedestrian crossings and 232 bicycle crossings. The equipment recorded video at the Minneapolis roundabout from September 18 to October 11, capturing 4,730 pedestrian crossings and 7,302 bicycle crossings.
