# Advanced LED Warning System for Rural Intersections: Phase 2 (ALERT-2)

Minnesota  
Department of  
Transportation

Research Project  
Final Report 2014-10

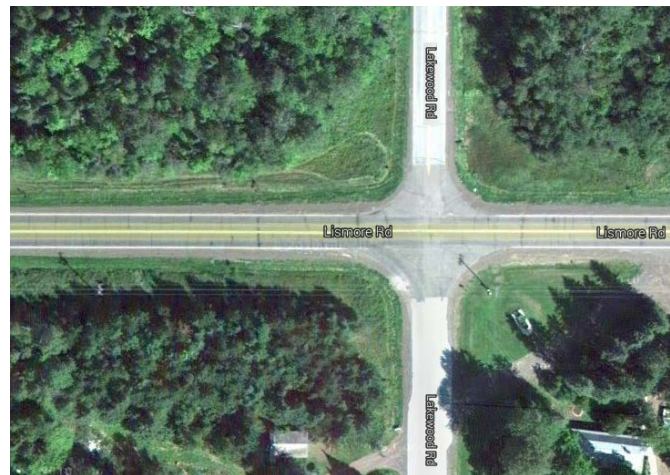
Figure 1: Satellite view of the ALERT-2 study intersection [11].

The project site chosen for the ALERT-2 system evaluation is at the intersection of Lismore Road and Lakewood Road, located north of Duluth, Minnesota. Lismore Road is the major road with a through condition, and Lakewood Road is the minor road with a stop condition. The speed limit of both roads is 55 mph (88.5 km/h). The Annual Average Daily Traffic (AADT) for Lismore Road is 970 vehicles per day, while Lakewood Road is 570 vehicles per day. A different site from the first phase of this study (ALERT-1) was chosen to eliminate any bias from “pre-conditioned” drivers. Figure 1 shows a satellite view of the chosen intersection.

A severe vertical curve exists on the west approach of Lismore Road which significantly reduces the available intersection sight distance for vehicles stopped on either the north or south approaches of Lakewood Road. Figure 2 shows the view of eastbound drivers in advance of the intersection with a blind vertical curve.

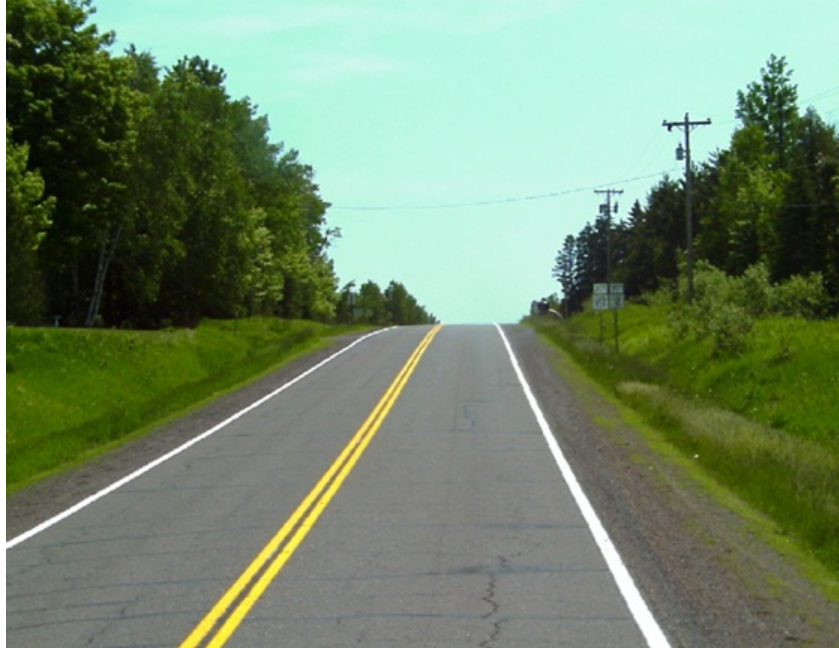
**Figure 2: Sight restriction of the intersection for drivers traveling from the west side of Lismore Road.**

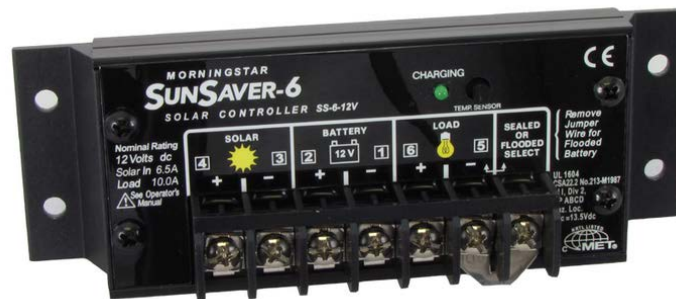
The charge controller used in this project is Morningstar SunSaver SS-6-12V (Figure 10). This charge controller is used for charging AGM batteries. The SunSaver-6 is rated for 12 V systems and uses an advanced series Pulse Width Modulation (PWM) charge control for constant voltage battery charging. The maximum solar array open circuit voltage is 30 V. The operating power consumption is 8 mA. Use of cooper wires between 10 AWG and 14 AWG are recommended. Therefore, 12-AWG wires are used to connect the charge controller with the solar panel and battery.

**Figure 10: Morningstar SunSaver-6 solar charge controller.**

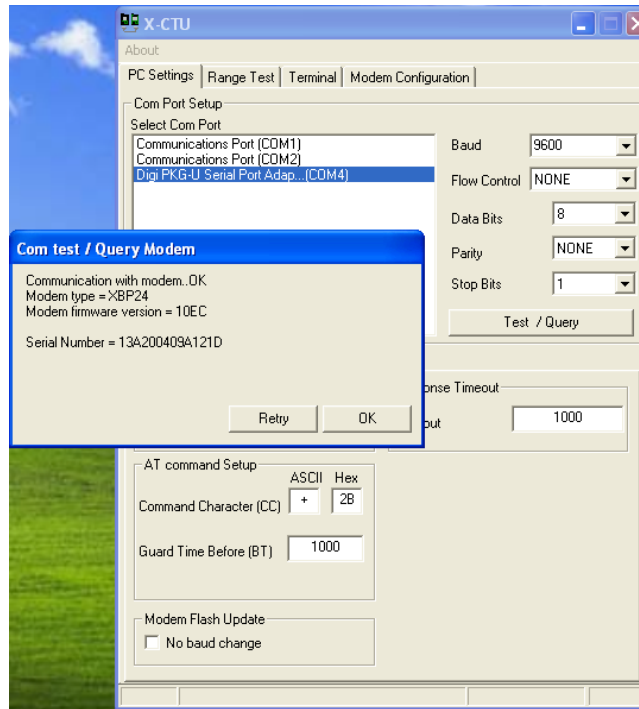
When the X-CTU software is launched, the default tab selected is the “PC Settings” tab. The PC settings tab allows the user to select the connected COM port and configure its settings when accessing the port. Some of these settings include the baud rate, flow control, data bits, parity, and stop bits. To test the selected COM port and PC settings, user can press the Test/Query button. If a successful connection is made, a message will pop up and display the module type, firmware version, and its MAC address. Figure 16 shows the default settings for a USB development board.

**Figure 13: PC Setting tab in the X-CTU software.**

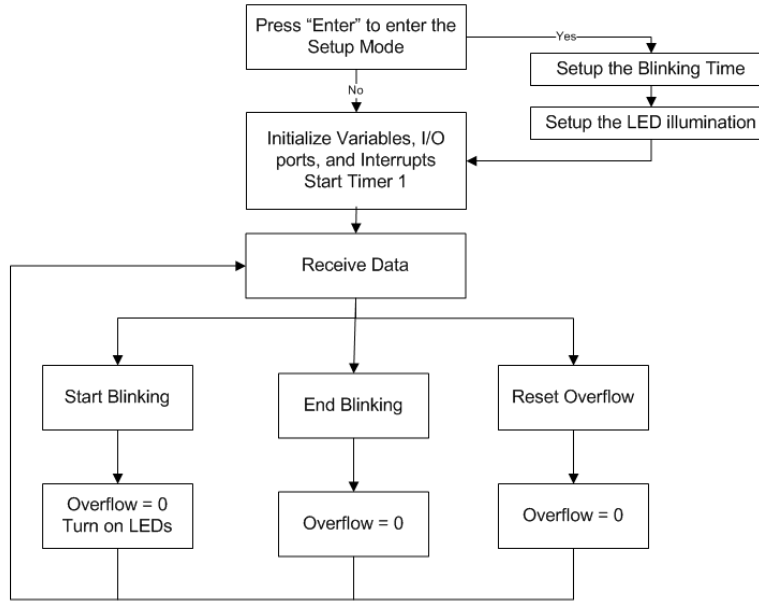
Blinker sign S1 is responsible for processing the wireless signals received from both of the radar detectors (D3 and D4). A software flow diagram for blinker sign S1 is illustrated in Figure 25. First, the user will be asked to press “Enter” to enter the setup mode or wait for 2 seconds to start the main routine. Two parameters can be set by the user through the HyperTerminal interface: the blinking time and the LED illumination. After insertion of the required parameter, the main routine starts with defining variables and initializing Ports A, B, C, and the Timer 1 interrupt. Then, the program waits for incoming data. Three types of signals can be received from either of the FMCW radar detectors: The first signal is a “START” blinking signal. When this signal is received, a vehicle has entered either one of the detection zones at the intersection. Here, the overflow counter is reset and the blinking LEDs are turned on. The second signal is an “END” blinking signal. When this signal is received, a vehicle has exited either one of the detection zones at the intersection. Here, the overflow counter is reset and the LEDs are turned off. The third signal is an “ALIVE” signal. When this signal is received, the overflow counter is reset. If a “START”, “END”, or “ALIVE” signal is not received from a Radar detector for more than 12 minutes, the blinker sign will enter fail safe mode and the LEDs will blink continuously, until receiving any new signal.

**Figure 22: Blinker 1 firmware flow diagram.**

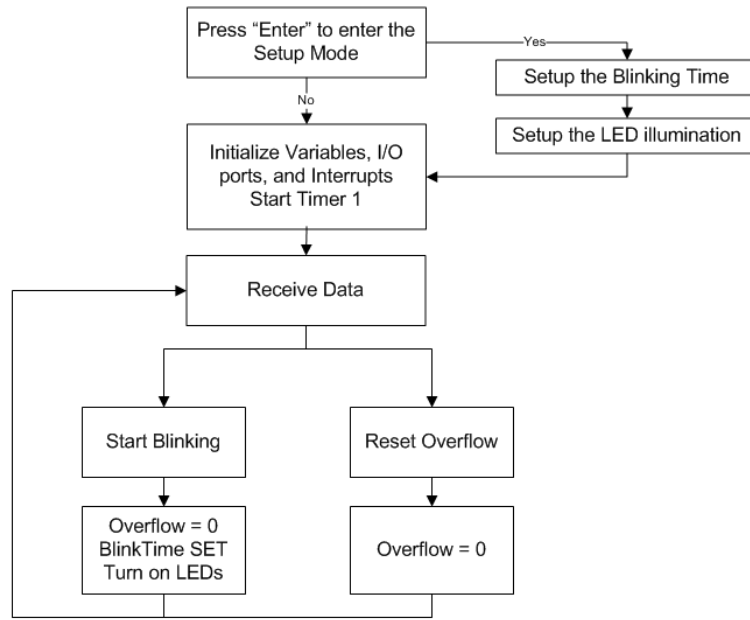
Blinker warning signs S2 and S3 are responsible for processing the wireless signals received from the Doppler radars D1 and D2, while the STOP Blinker signs S5 and S6 are responsible for processing the wireless signals received from the Doppler radars D5 and D6. The software flow diagram is illustrated in Figure 26. First, the user is asked to press “Enter” to enter the setup mode or wait for 2 seconds to automatically start the main routine. Two parameters can be set by the user through the HyperTerminal interface: the blinking time and the LED illumination. In the main routine, variables, Port A, Port B, Port C, and Timer 1 and its interrupt routine are initialized. Then, the program waits for incoming data from the Doppler detectors. Two types of signals can be received from a Doppler detector. The first signal is a “START” blinking signal. When this signal is received, it indicates that a vehicle has been detected. Here, the overflow counter is reset, the “BLINKTIME” variable is set to 9.5 seconds for S2 and S3, and 10 seconds for S4 and S6, and the blinking cycles of LEDs are turned on. The blinking LEDs are turned off when the “BLINKTIME” variable reaches zero. If another “START” signal has been received before the “BLINKTIME” variable reaches zero, the “BLINKTIME” variable is reset. The second signal is an “ALIVE” signal. When this signal is received, the overflow counter is reset. If either a “START” or “ALIVE” signal is not received from the Doppler detector for more than ten minutes, the blinker sign will enter the default mode, and the LEDs will blink continuously until a new signal is received.

**Figure 23: S2, S3, S4 and S6 firmware flow diagram.**

When a detector unit completely fails such as out of battery, it will be unable to send an “ALIVE” signal to its respective blinker sign. A fail-safe mode has been implemented into each blinker sign based on a timeout. If a blinker sign has not received any type of wireless signals for more than twelve minutes, it will enter into the fail safe mode and the LEDs will continuously blink until a new data is received. This assures that if a vehicle detector is not working but sign is working, the blinker sign is automatically switched into a traditional blinker sign which continuously blinks.

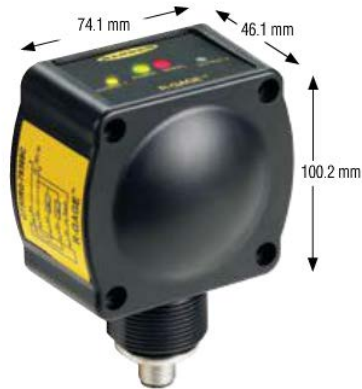
The FMCW Radar detector tested is the Banner R-Gage QT50RAF Sensor (Figure 28). This radar is the same radar used in the first phase, ALERT-1, with the same configuration. This radar sensor uses Frequency Modulated Continuous-Wave (FMCW) radar. It transmits a frequency sweep, often called a chirp which is reflected from distant targets and detected by the receiver. By measuring the frequency of the return signal, the time delay between transmission and reception can be measured, and thus the range is determined. Advantages of this sensor are that it can detect both moving and stationary objects. Also, using the R-Gage Radar sensor allows to set a detection zone near each stop sign. Vehicles are detected as they enter the detection zone and remain detected until they leave the detection zone. The sensor can be configured (via DIP switch) to sense objects up to a specific distance, ignoring objects beyond this distance. The detection zone is typically set between 3m – 15m from the sensor. Also, the sensitivity, output configuration, and response speed can be adjusted. Figure 29 describes the radar LED indicators. Figure 28 shows the Banner R-Gage Radar sensor.

**Figure 25: Banner R-Gage QT50RAF radar [19].**

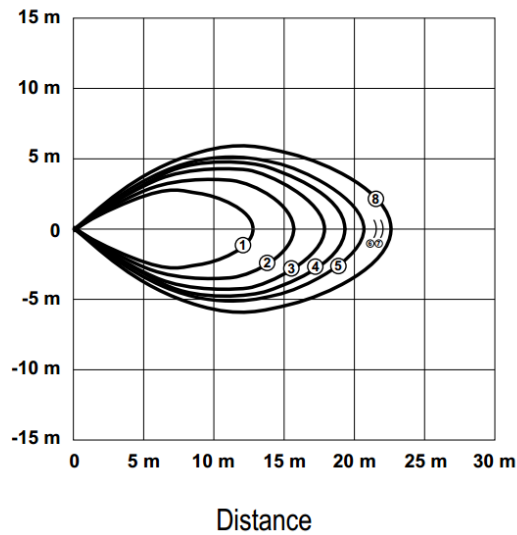
**Figure 28: Typical beam pattern for different sensitivity levels of the R-Gage radar sensor [19].**

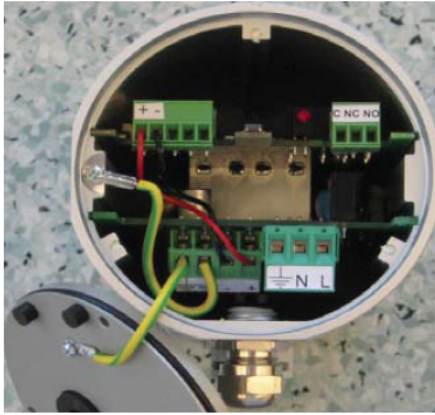
1	V+ Supply	Brown
2	V- Ground	White
3	res	
4	res	
5	res

**Figure 31: Doppler radar connections [20].**

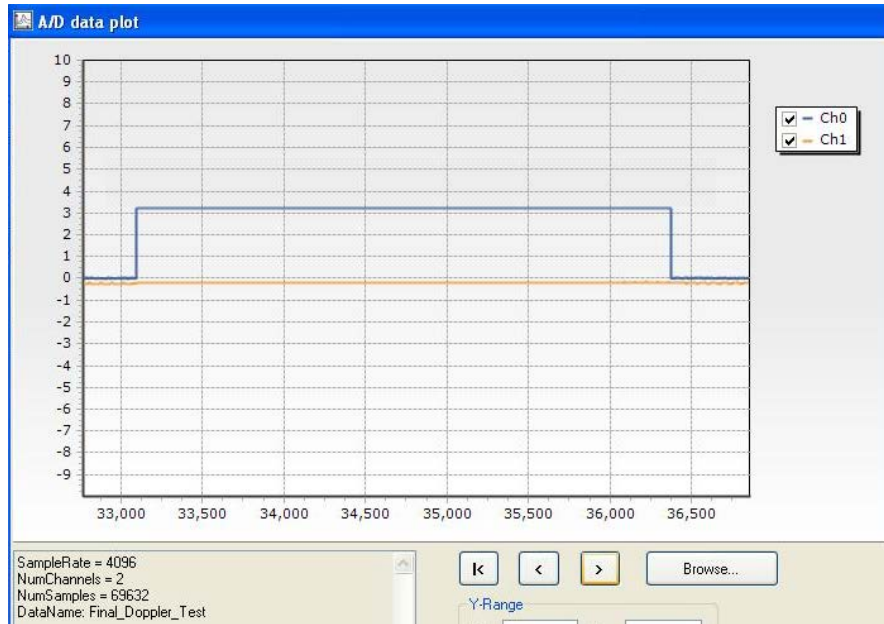
**Figure 32: Doppler radar output signal.**

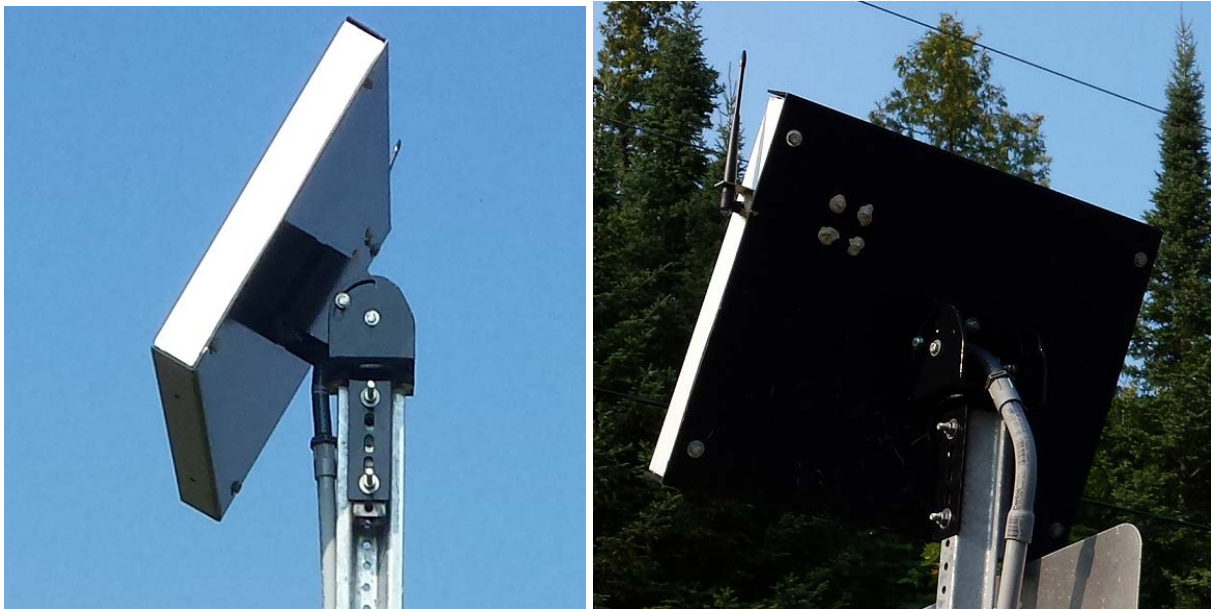
The solar panel used in the ALERT-2 system is the bp Solar SX 420J. A custom designed enclosure was used to mount the solar panel. It allows the wireless module to be mounted inside the solar panel housing using four small attaching screws. The solar panel is attached to its enclosure via four self-tapping screws. Rubber weather strips along with the edges of the solar panel housing creates a seal when the two units are screwed together. This protects the wireless module inside from rain and snow. The antenna is mounted on the outside of the solar panel in either left or right upper corner and connected to the wireless module. All screw holes are sealed with white DAP Adhesive Caulk Seal. Each assembled solar panel and housing is attached to a solar panel mounting bracket. This bracket is designed to mount the solar panel to a u-channel sign post. It also allows the solar panel to be adjusted both horizontally and vertically. Figure 41 shows pictures of the solar panel housing and its mounting bracket. Each solar panel has seven connection wires, each wire with 12ft length to make the connection from the solar panel to the battery cabinet. Table 16 summarizes the solar panel wiring details.

Figure 38: Solar panel housing and its mounting bracket.

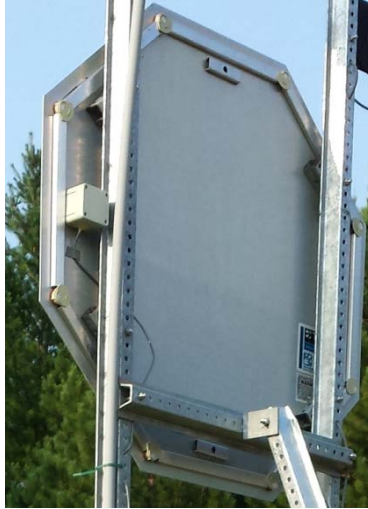
Typical blinker signs commercially available contain electronic control circuits and battery on the back of the sign. The blinker signs purchased for this project contains no electronic circuits and batteries, except LEDs on the perimeter of the sign. A small junction box was attached on the back side of the blinker sign to connect wires from the control cabinet which contains battery and the control circuit. Figure 42 shows the back side of a blinker sign.

**Figure 39: Back side of a blinker sign.**

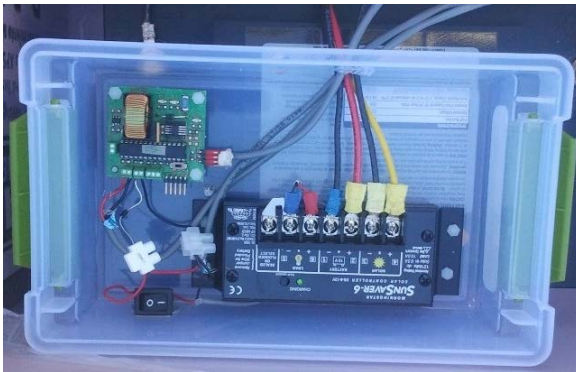
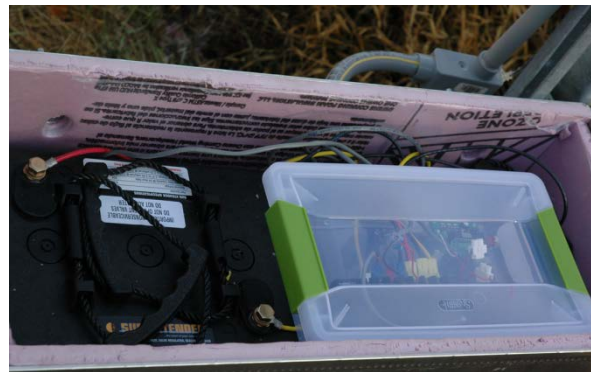
Control circuits consist of a battery charger and a controller for LED activation and communication. These controllers are designed as plug-and-play devices and thus do not require any settings. Only requirement is connecting the wires correctly. Since its size is small, it is simply placed inside a small plastic box of the battery enclosure as shown in Figure 43.

**Figure 40: A clear plastic box is used to house controller circuits and placed inside the battery enclosure.**

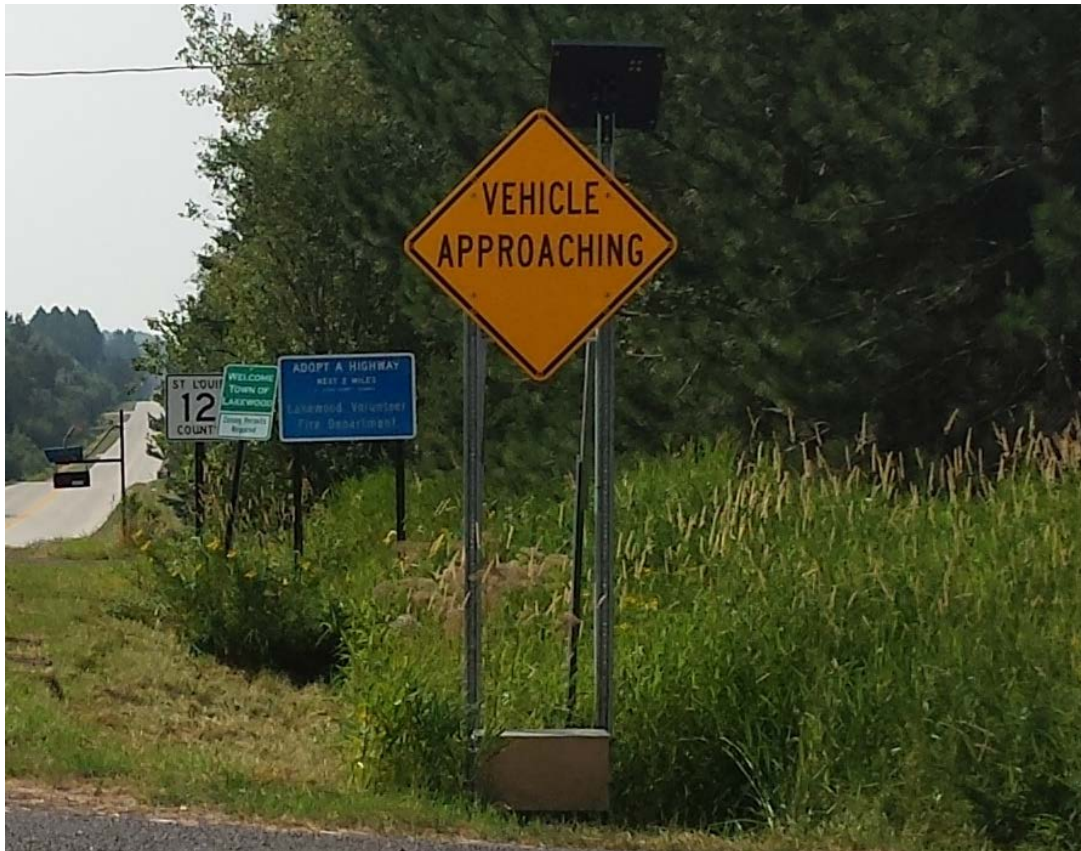
Figure 43: Finished “VEHICLE APPROACHING” blinker sign.

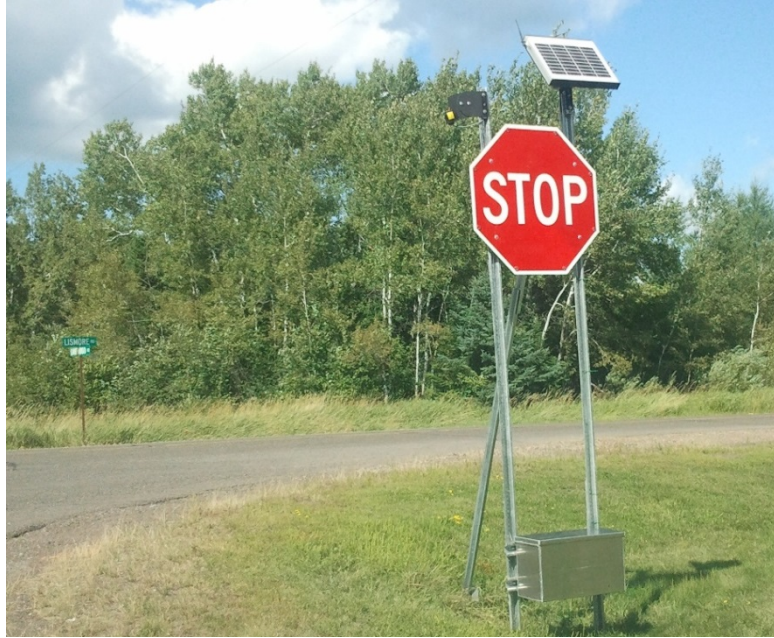
**Figure 46: Finished FMCW radar unit.**

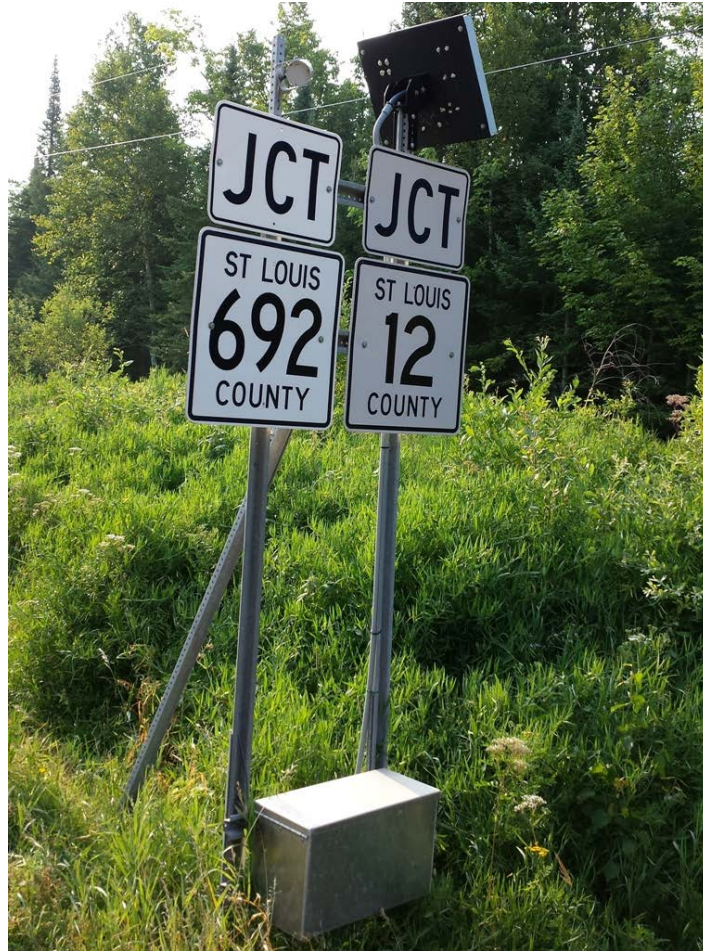
**Figure 48: Installed Doppler radar unit (D1) on the major road.**

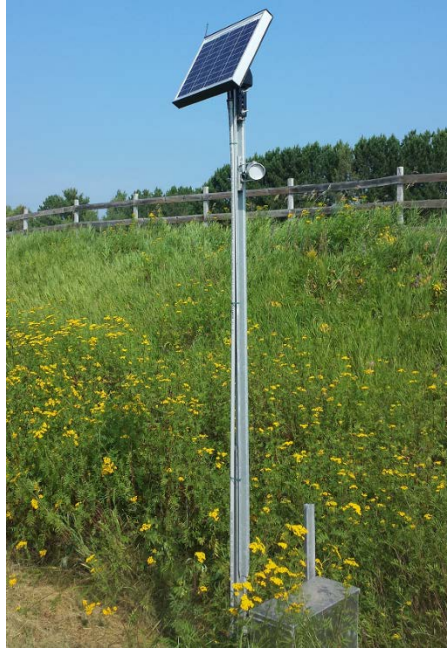
**Figure 49: Installed Doppler radar unit (D2) on the major road.**

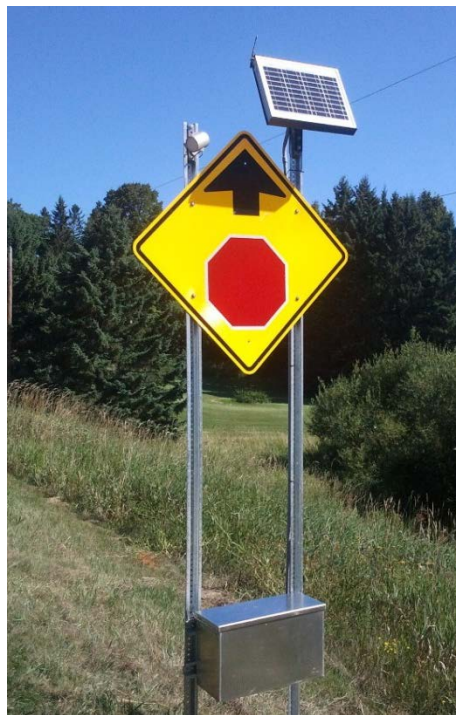
**Figure 50: Installed Doppler radar unit (D5) on the minor road.**

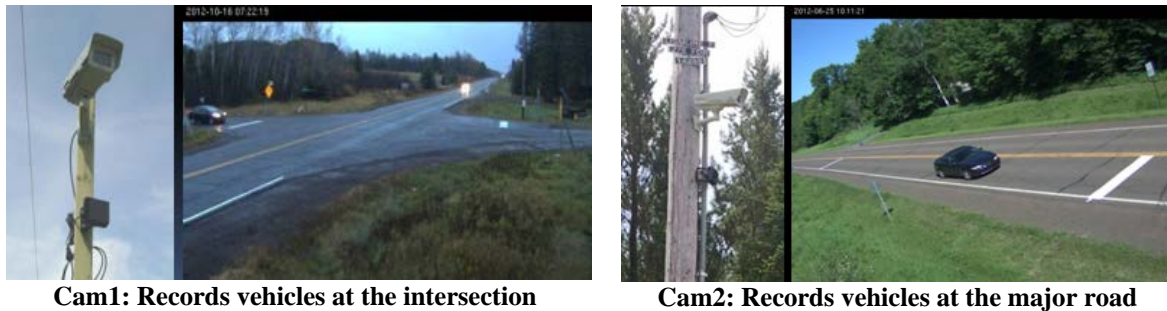
Figure 52: Network cameras and data samples.

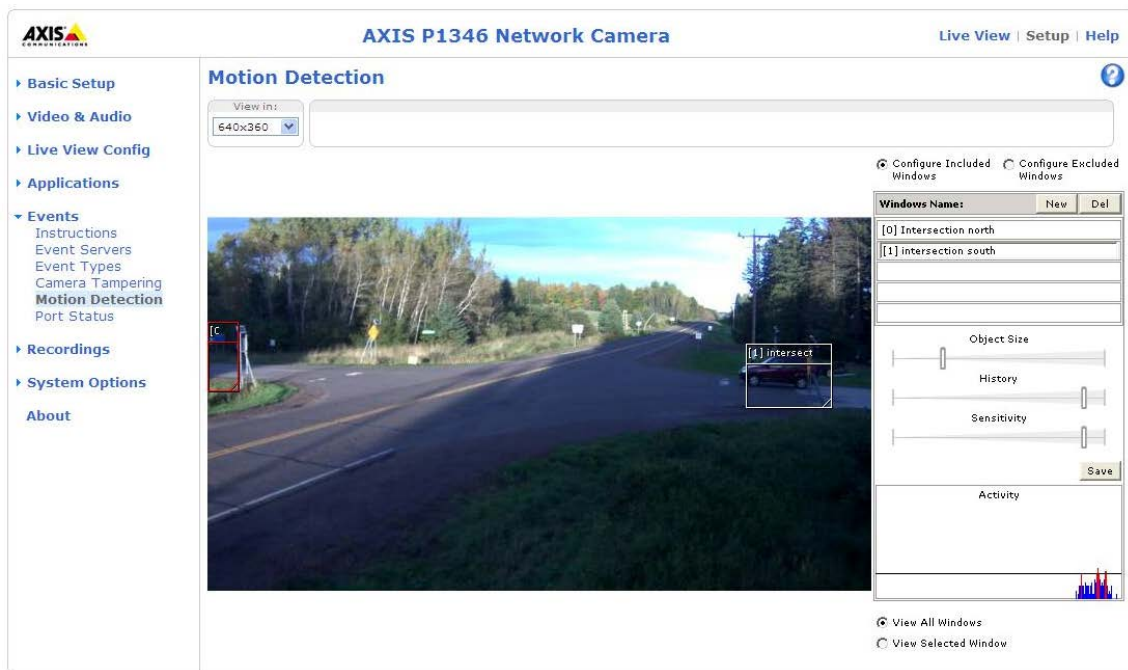
**Figure 53: Network camera motion detection setup page.**

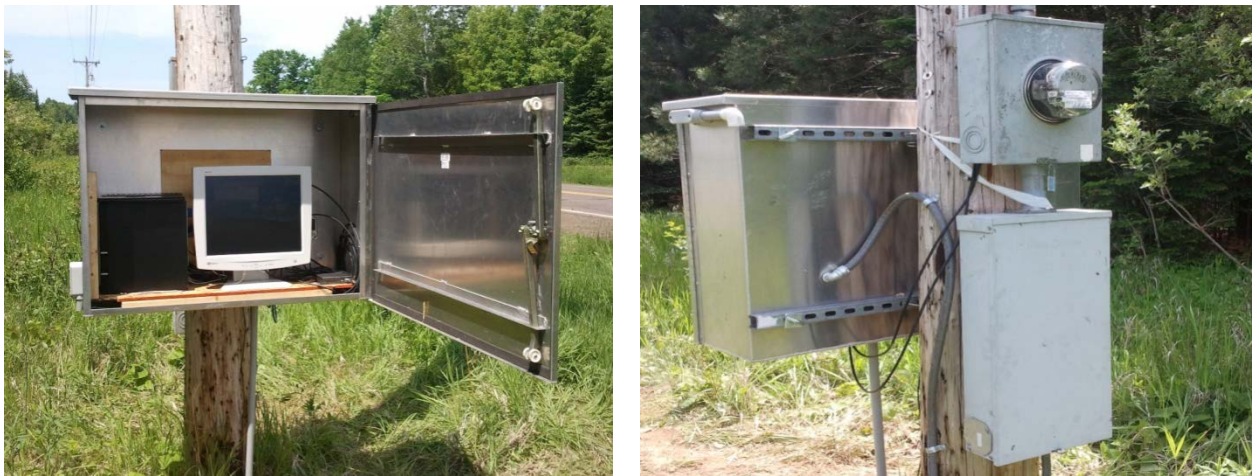
**Figure 54: Data collection cabinet front view (left) and back view (right).**

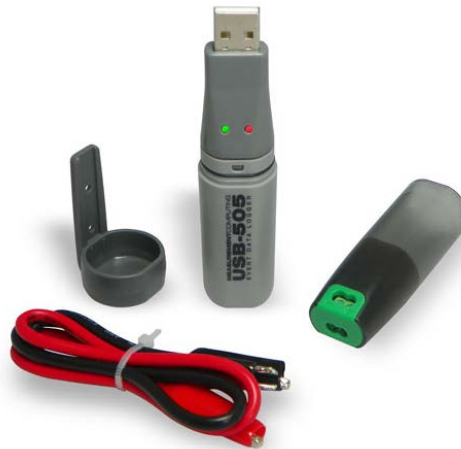
**Figure 55: USB-505 event-data logger [23].**
