## TECHNICAL SUMMARY

# Manual Gives Cost-Effective Techniques to Extend Timber Bridge Life Spans

*This Technical Summary pertains to the LRRB-produced Reports 2015-45A, “Development of Cost-Effective Timber Bridge Repair Techniques for Minnesota,” and 2015-45B, “Cost-Effective Timber Bridge Repairs: Manual for Repairs of Timber Bridges in Minnesota,” both published in November 2015. The full reports can be accessed at [mndot.gov/research/TS/2015/201545A.pdf](http://mndot.gov/research/TS/2015/201545A.pdf) and [mndot.gov/research/TS/2015/201545B.pdf](http://mndot.gov/research/TS/2015/201545B.pdf).*

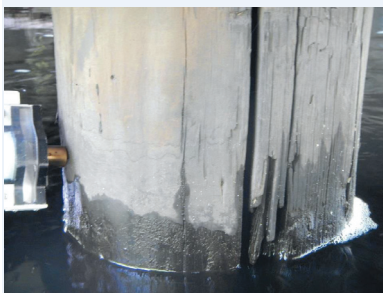
Timber bridges often develop issues, such as pile splitting, at the waterline.

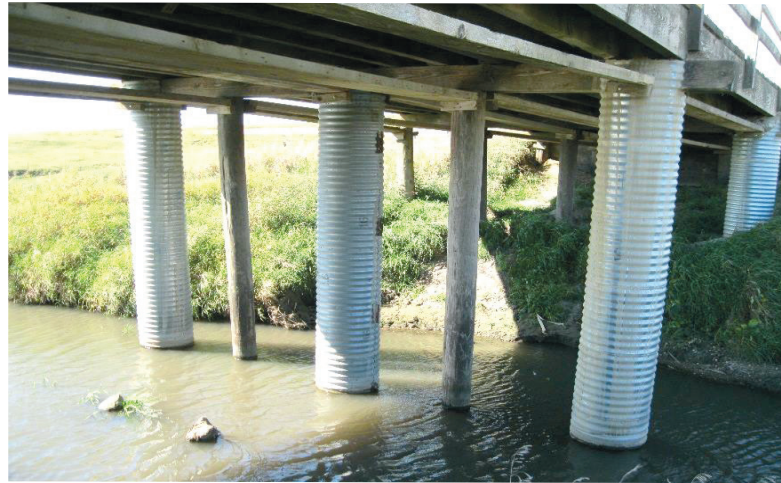
Concrete pile jackets—concrete-filled steel shells installed to strengthen timber piles weakened by minor to moderate deterioration—are one of the rehabilitation procedures detailed in the timber bridge repair manual.

- Repair of laminated bridge decks.
- Strengthening of individual timber stringers.
- Addition of steel channels to piles.
- Addition of reinforced concrete jackets to piles.
- Encapsulation of pile groups.
