TECHNICAL SUMMARY

Evaluation of Paving Fabrics for Isolation of Bituminous Cracking

This Technical Summary pertains to the LRRB-produced Report 2008-02, “Evaluation of Paving Fabrics for Isolation of Bituminous Cracking,” published January 2008. The full report can be accessed at <http://www.lrrb.org/PDF/200802.pdf>.

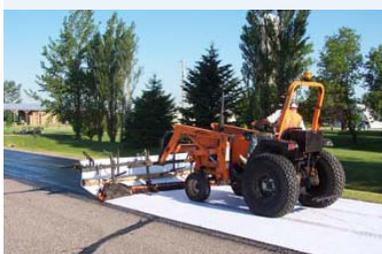
A contractor lays spun-glass paving fabric over asphalt before overlay.

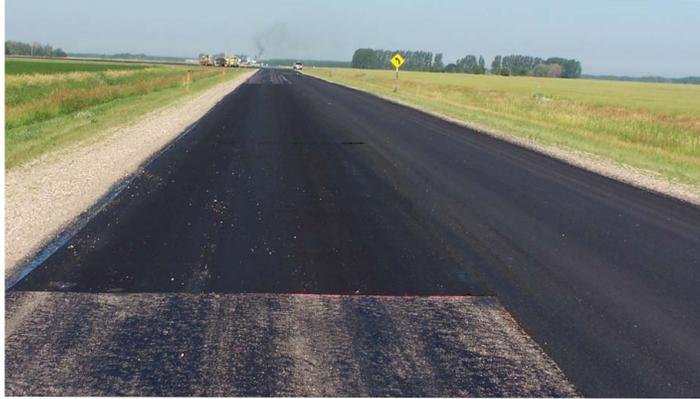
After applying a 0.5-inch blade asphalt leveling course, contractors laid paving fabric and overlaid it as in the left lane shown above. The fabric demonstrated no real benefit over sections without fabric.

According to our evaluation criteria, the fabric performed poorly, countering the claims of pavement fabric vendors. While spun-glass paving fabric can isolate heavy crack sealant from new overlays at less expense than milling and replacing asphalt with sealant, the use of paving fabric between asphalt layers added no structural strength and failed to retard early thermal and centerline cracking. Fabric sections and control sections with no fabric performed equally in terms of distress cracking. This cracking did not reflect through overlays in the first two years following installation. Investigators concurrently examined the impact of subjecting pavement sections to a 0.5-inch leveling course before overlay instead of milling them. They found that this practice also mitigates heavy crack sealant effects on main courses.
