Development and Integration of Advanced Timber Bridge Inspection Techniques for NBIS

Brian Brashaw, Principal Investigator
Natural Resources Research Institute
University of Minnesota Duluth

Research Project
Final Report 2015-01

**BRIDGE # 69529
CSAH 52 over DITCH**

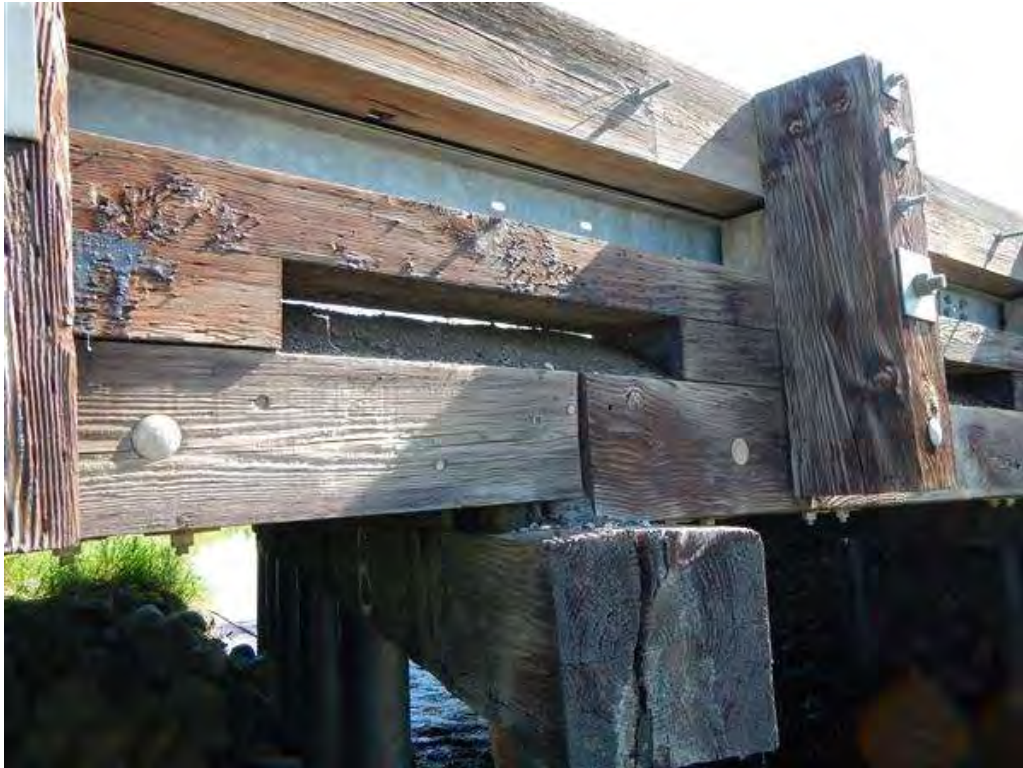
Notes: [2013] Timber pier cap showed significant visual vertical cracking caused by water infiltration at cap ends and excess weathering. Fakopp SWT were >500 microseconds for pier 1 along almost complete length. See attached sketch file. Resistance drilling completed (files 3-6) showed no evidence of decay but the presence of vertical crack causing high SWT. Significant moisture problems in pier 1 showed MC >25%. Visual water dripping through deck and into the exposed end from the deck. Pier 2 showed normal SWT (180-250 microseconds/ft transverse). Some evidence of vertical through crack on south end pier 2.

Photo 10 - Pier 2 North end - Through split extending 14" into cap.

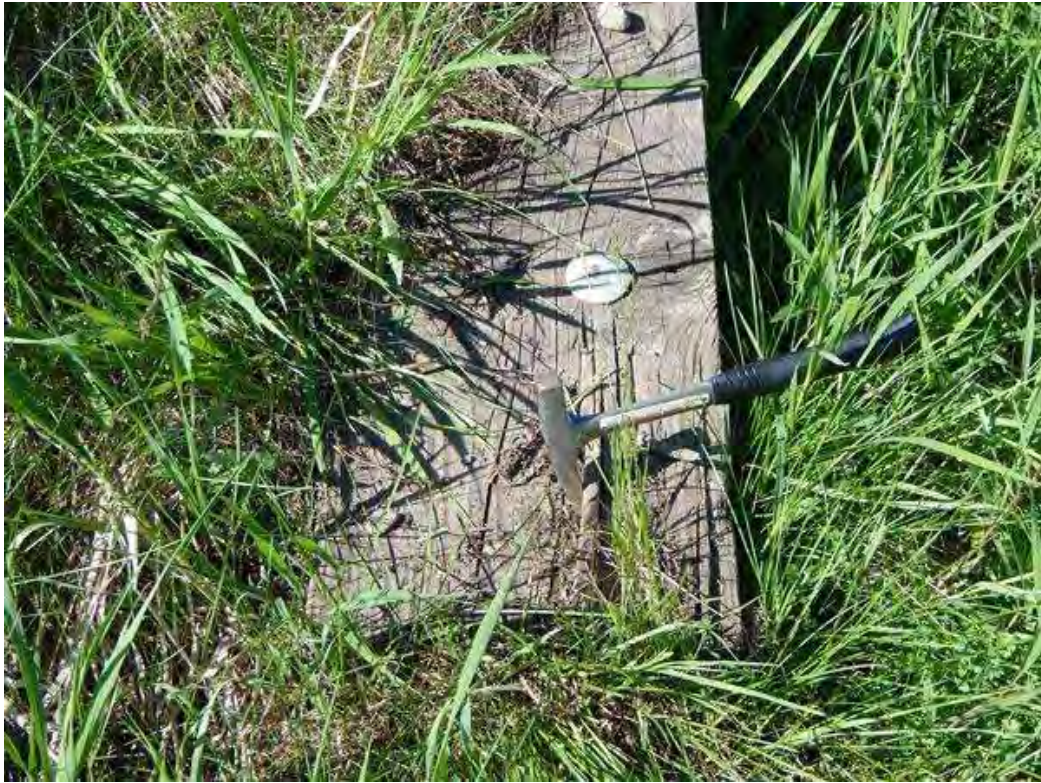
Notes: [2013] NW cap showed severe decay in pile. NE cap 50% decayed as it was almost fully covered by vegetation. SW Wing pile showed decay.

Photo 15 - Wing wall - NE

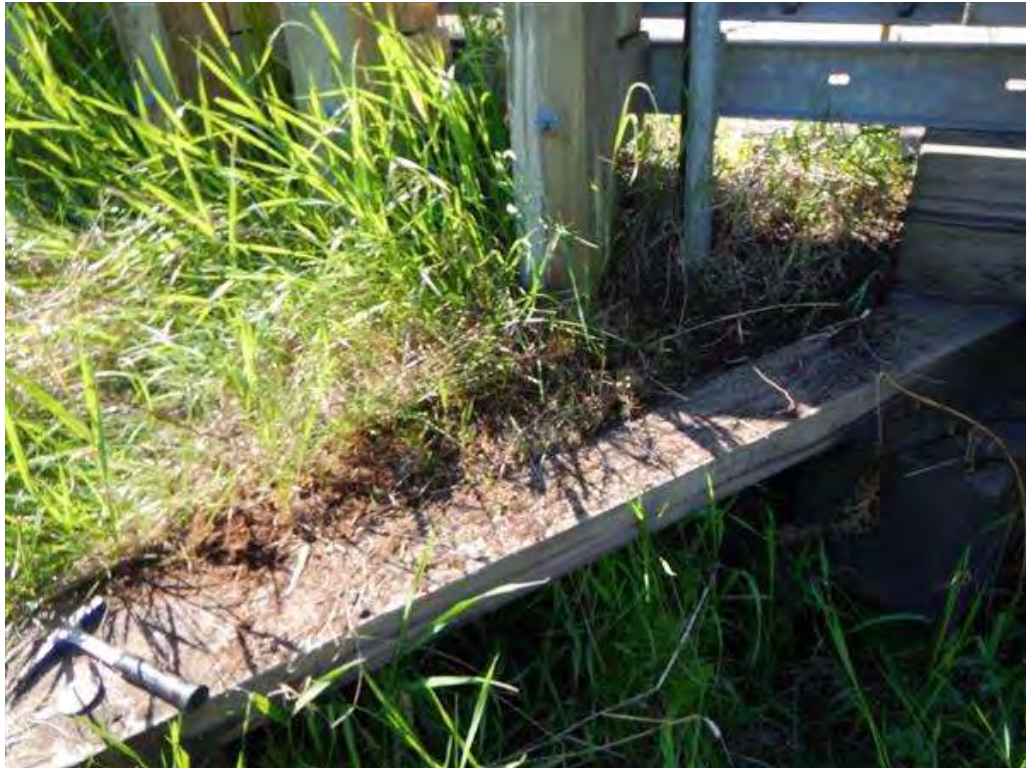
Photo 16 - Wing wall - NE

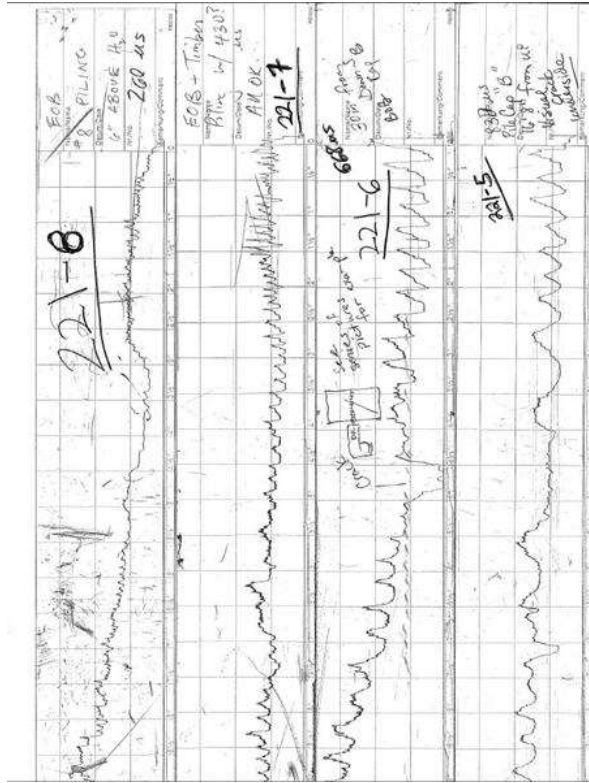
Photo 19 - Resistance drill data

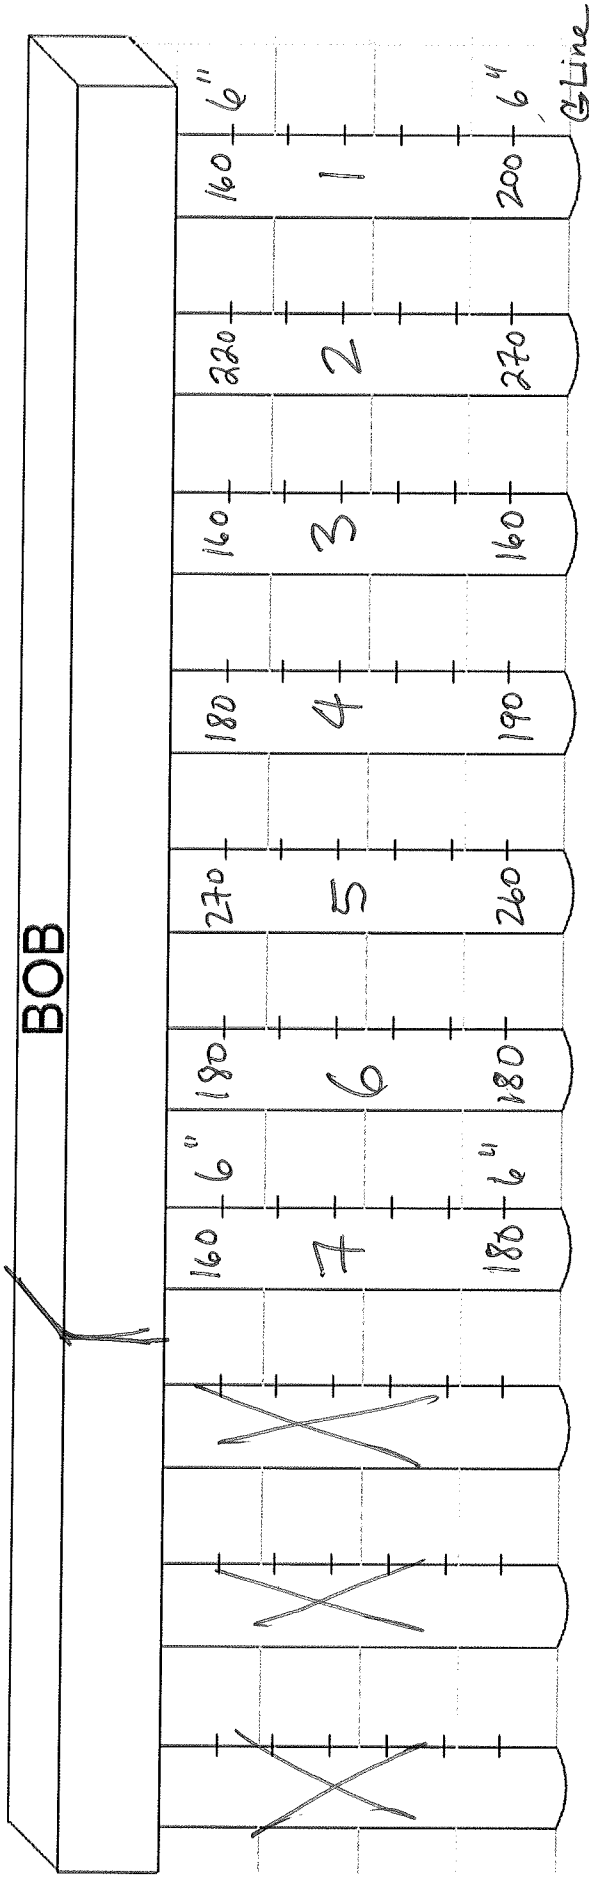
Notes: Timber pilings. Minimal surface checking. Stress wave timer shows good condition on all pilings. Full cross-section sound.

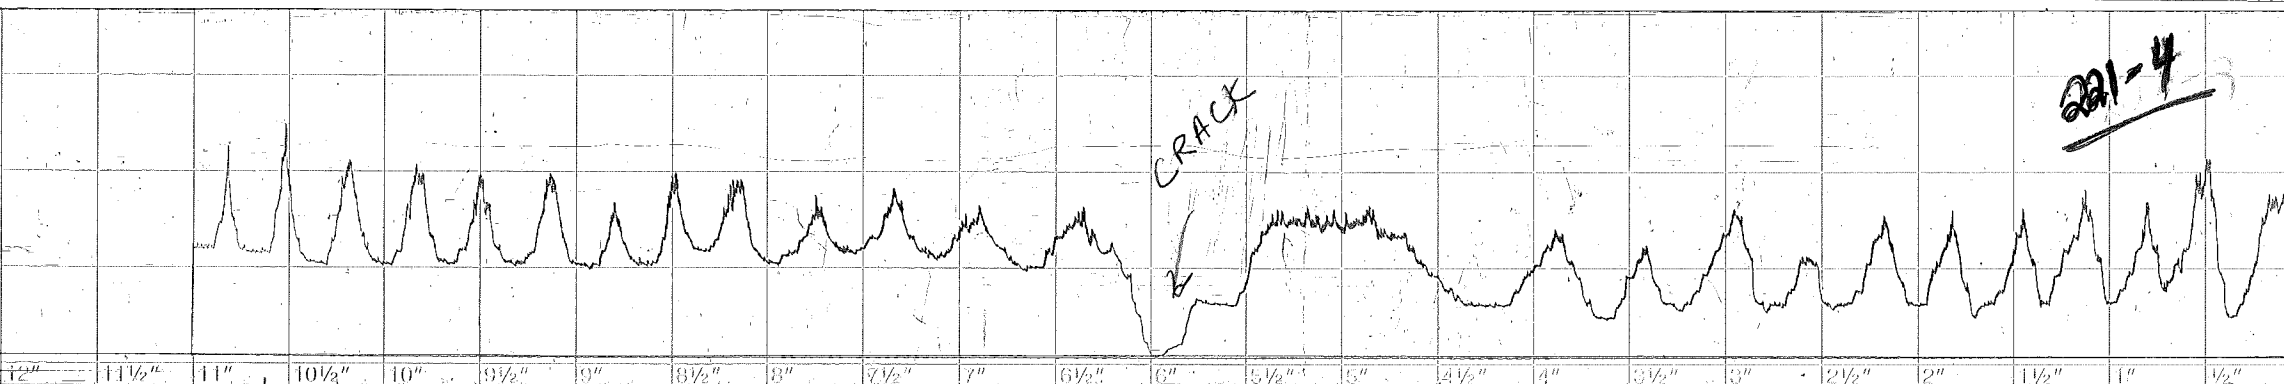
Name/Name: Bob Pile Cap "B"
 Datum/Date: Drilled at 7'3" from up
 Nr./No.: Seems OK
 Bemerkung/Comment:

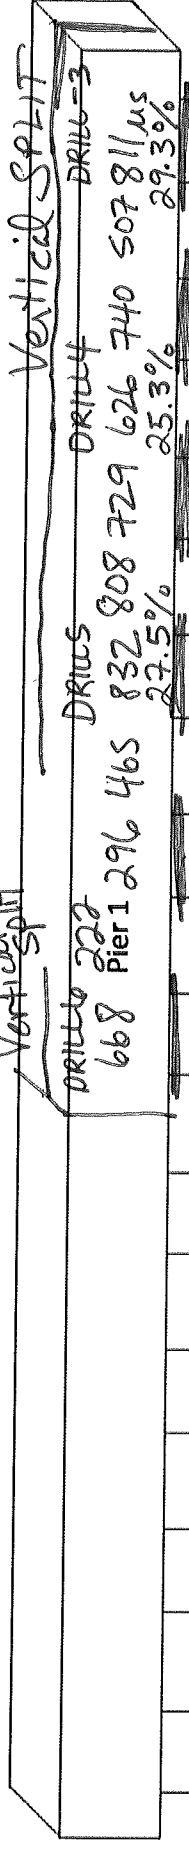
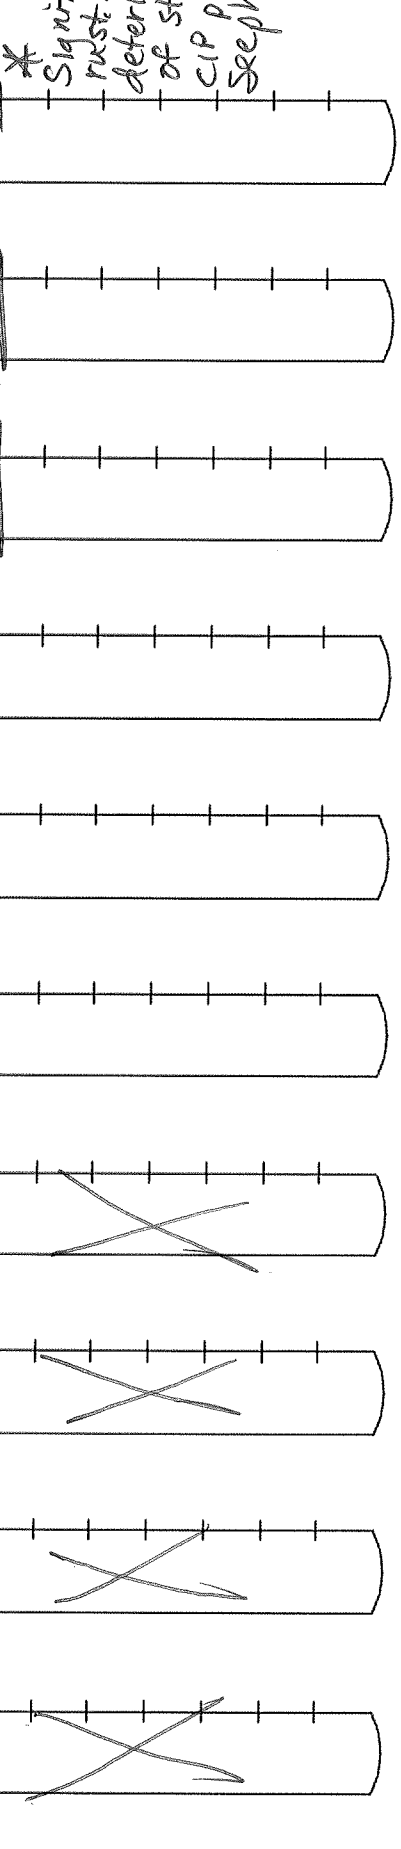
Vertical Split

* Significant rust and deterioration of steel CIP plate. See photos.

Notes: All pilings CIP. Through splits are present on both the upstream and downstream pier cap. Moisture measures are above 25% MC. Moisture is entering splits from ends and through deteriorated bituminous wear layer. Resistance drill data confirms split, but does not indicate decay.
